Montecito Sanitary District's Response to the Thomas Fire 1/9 Debris Flow Event

July 17, 2018

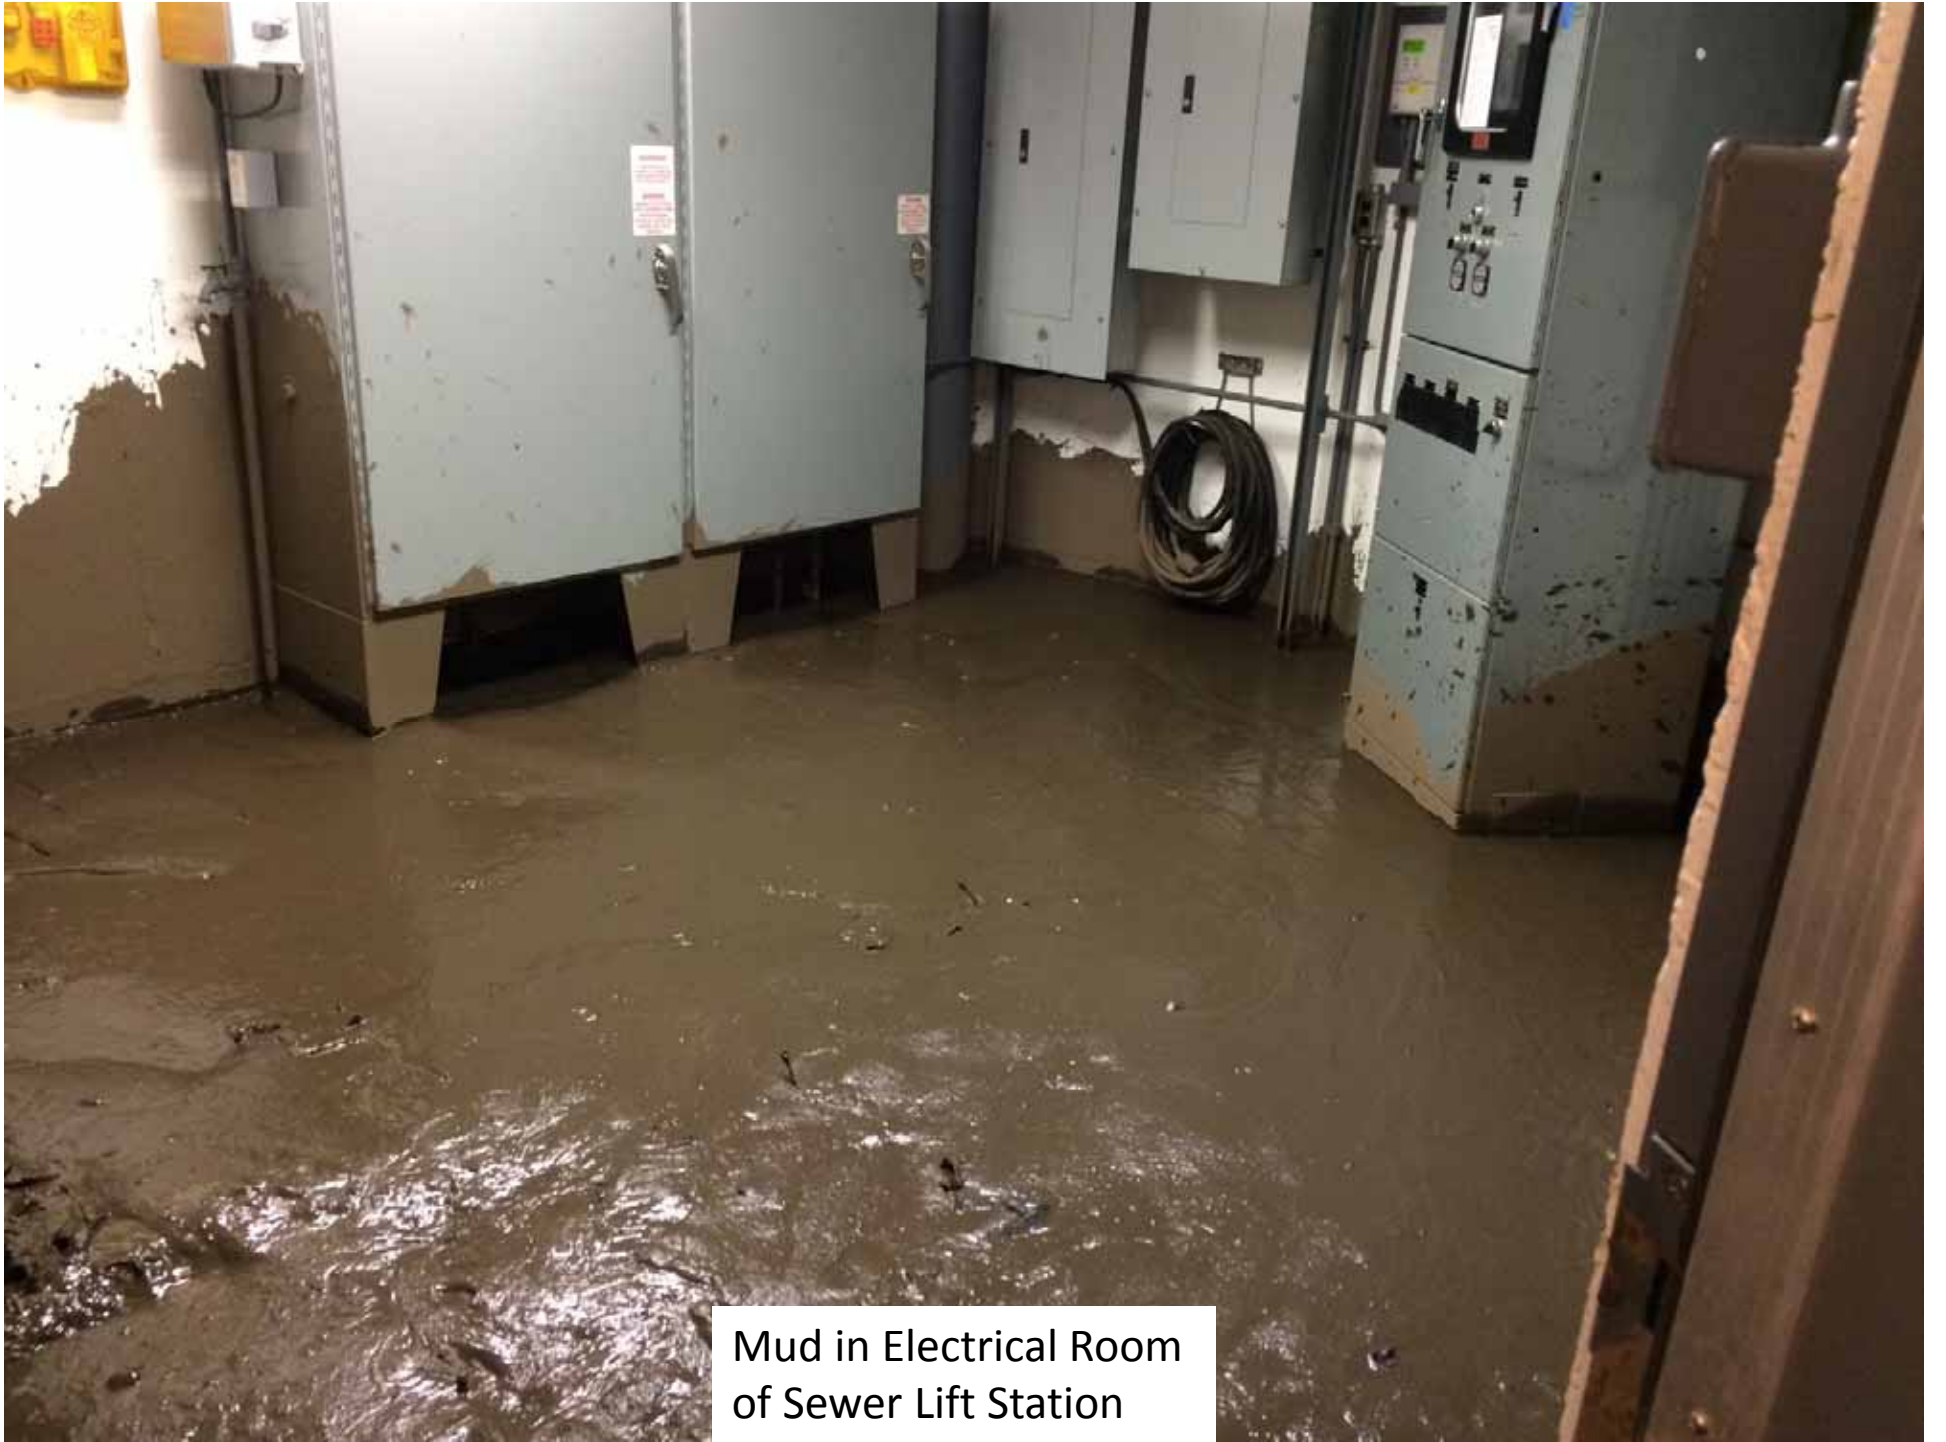
Mud in Electrical Room
of Sewer Lift Station

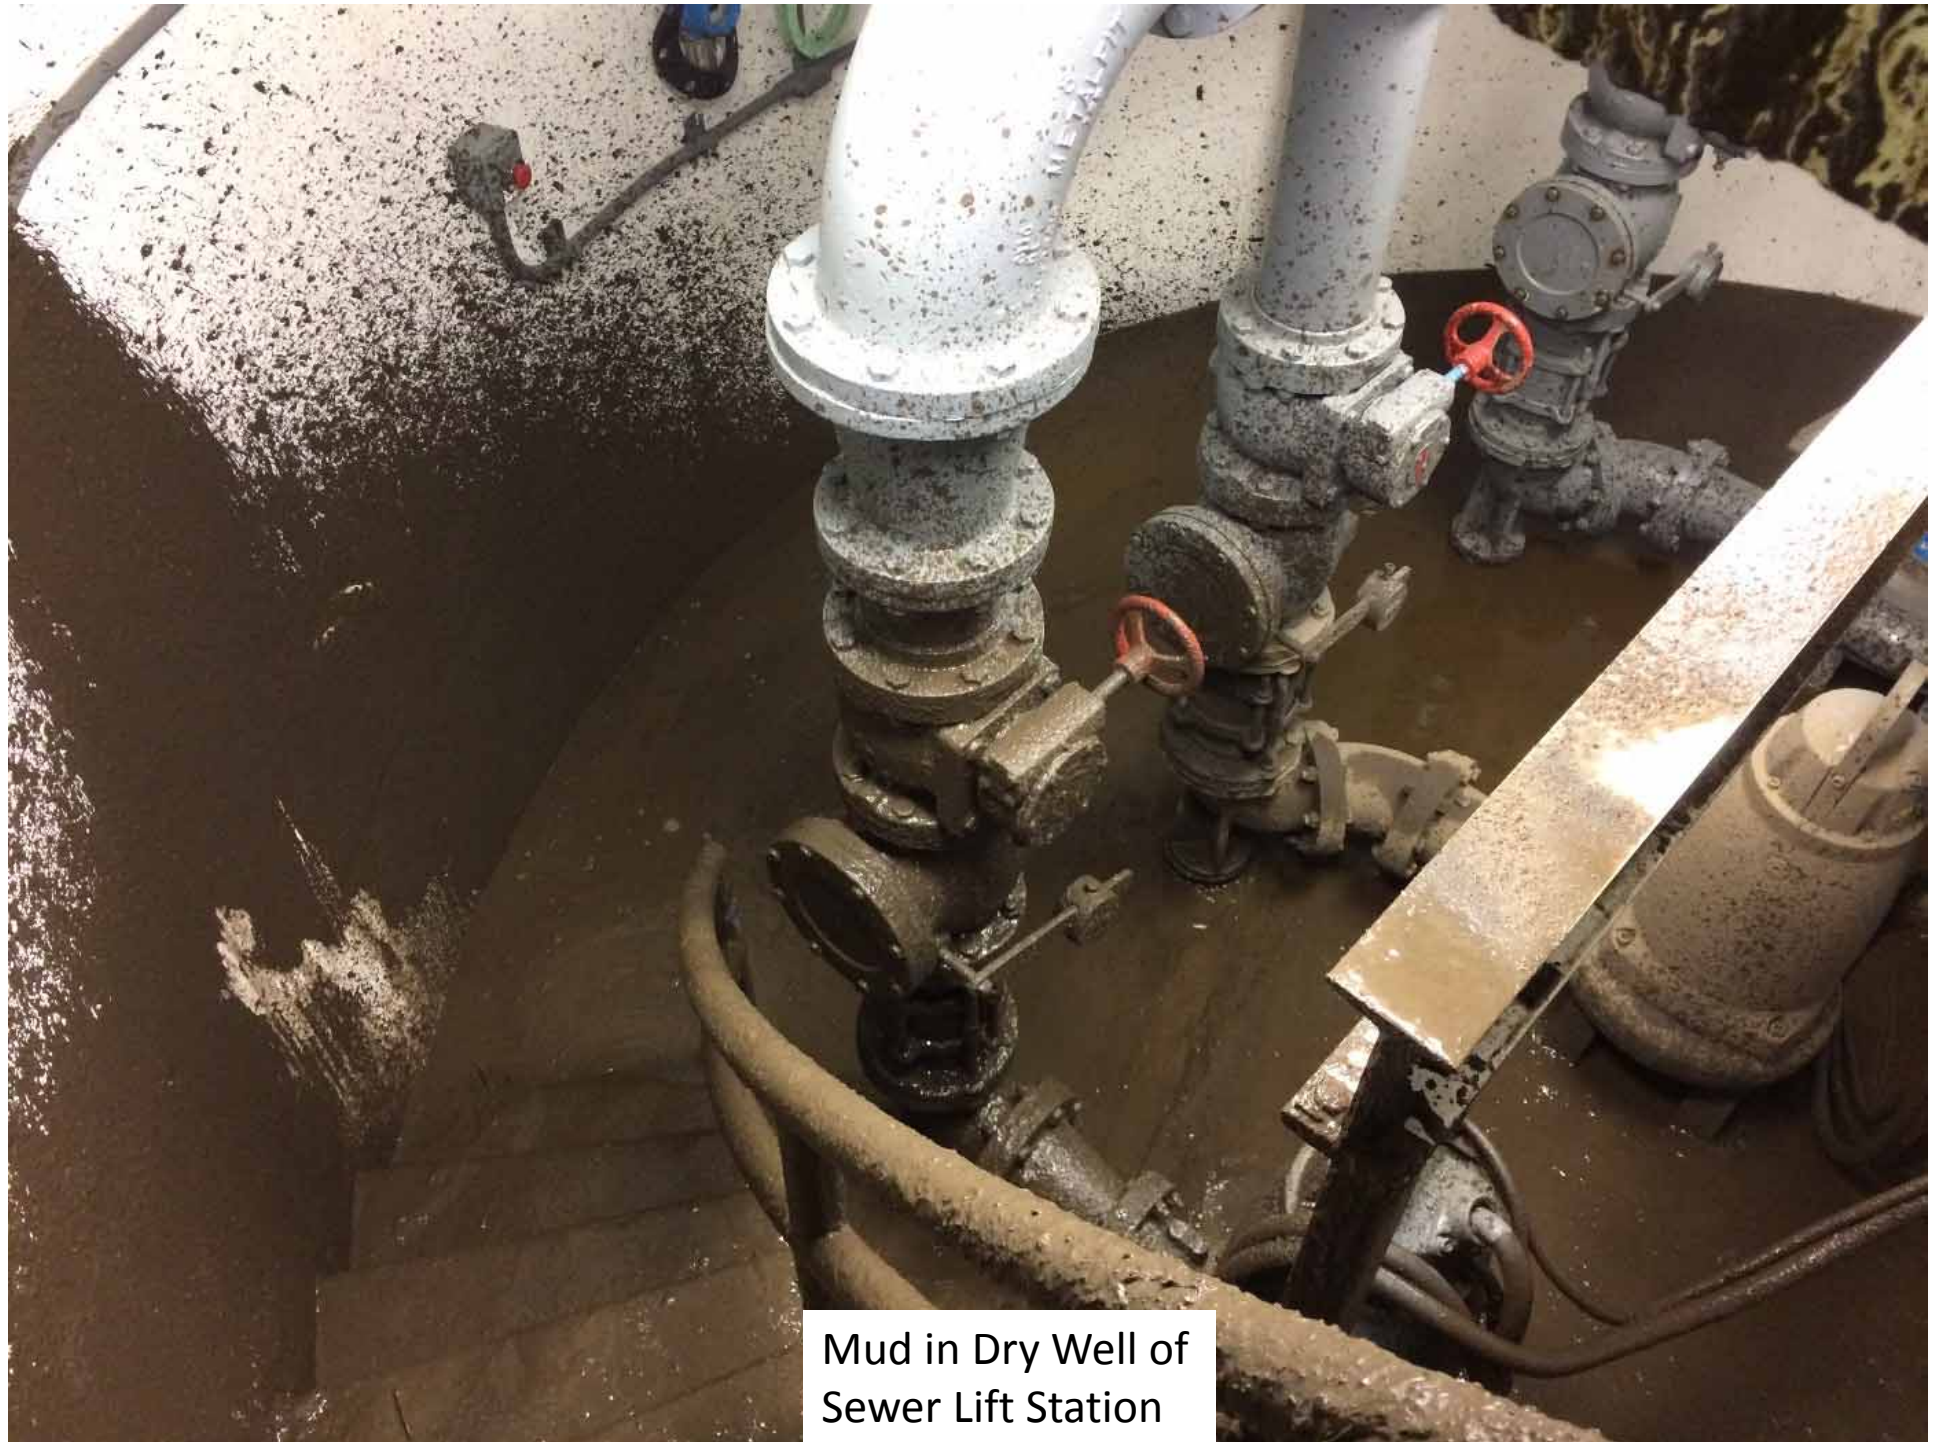
Mud in Dry Well of
Sewer Lift Station

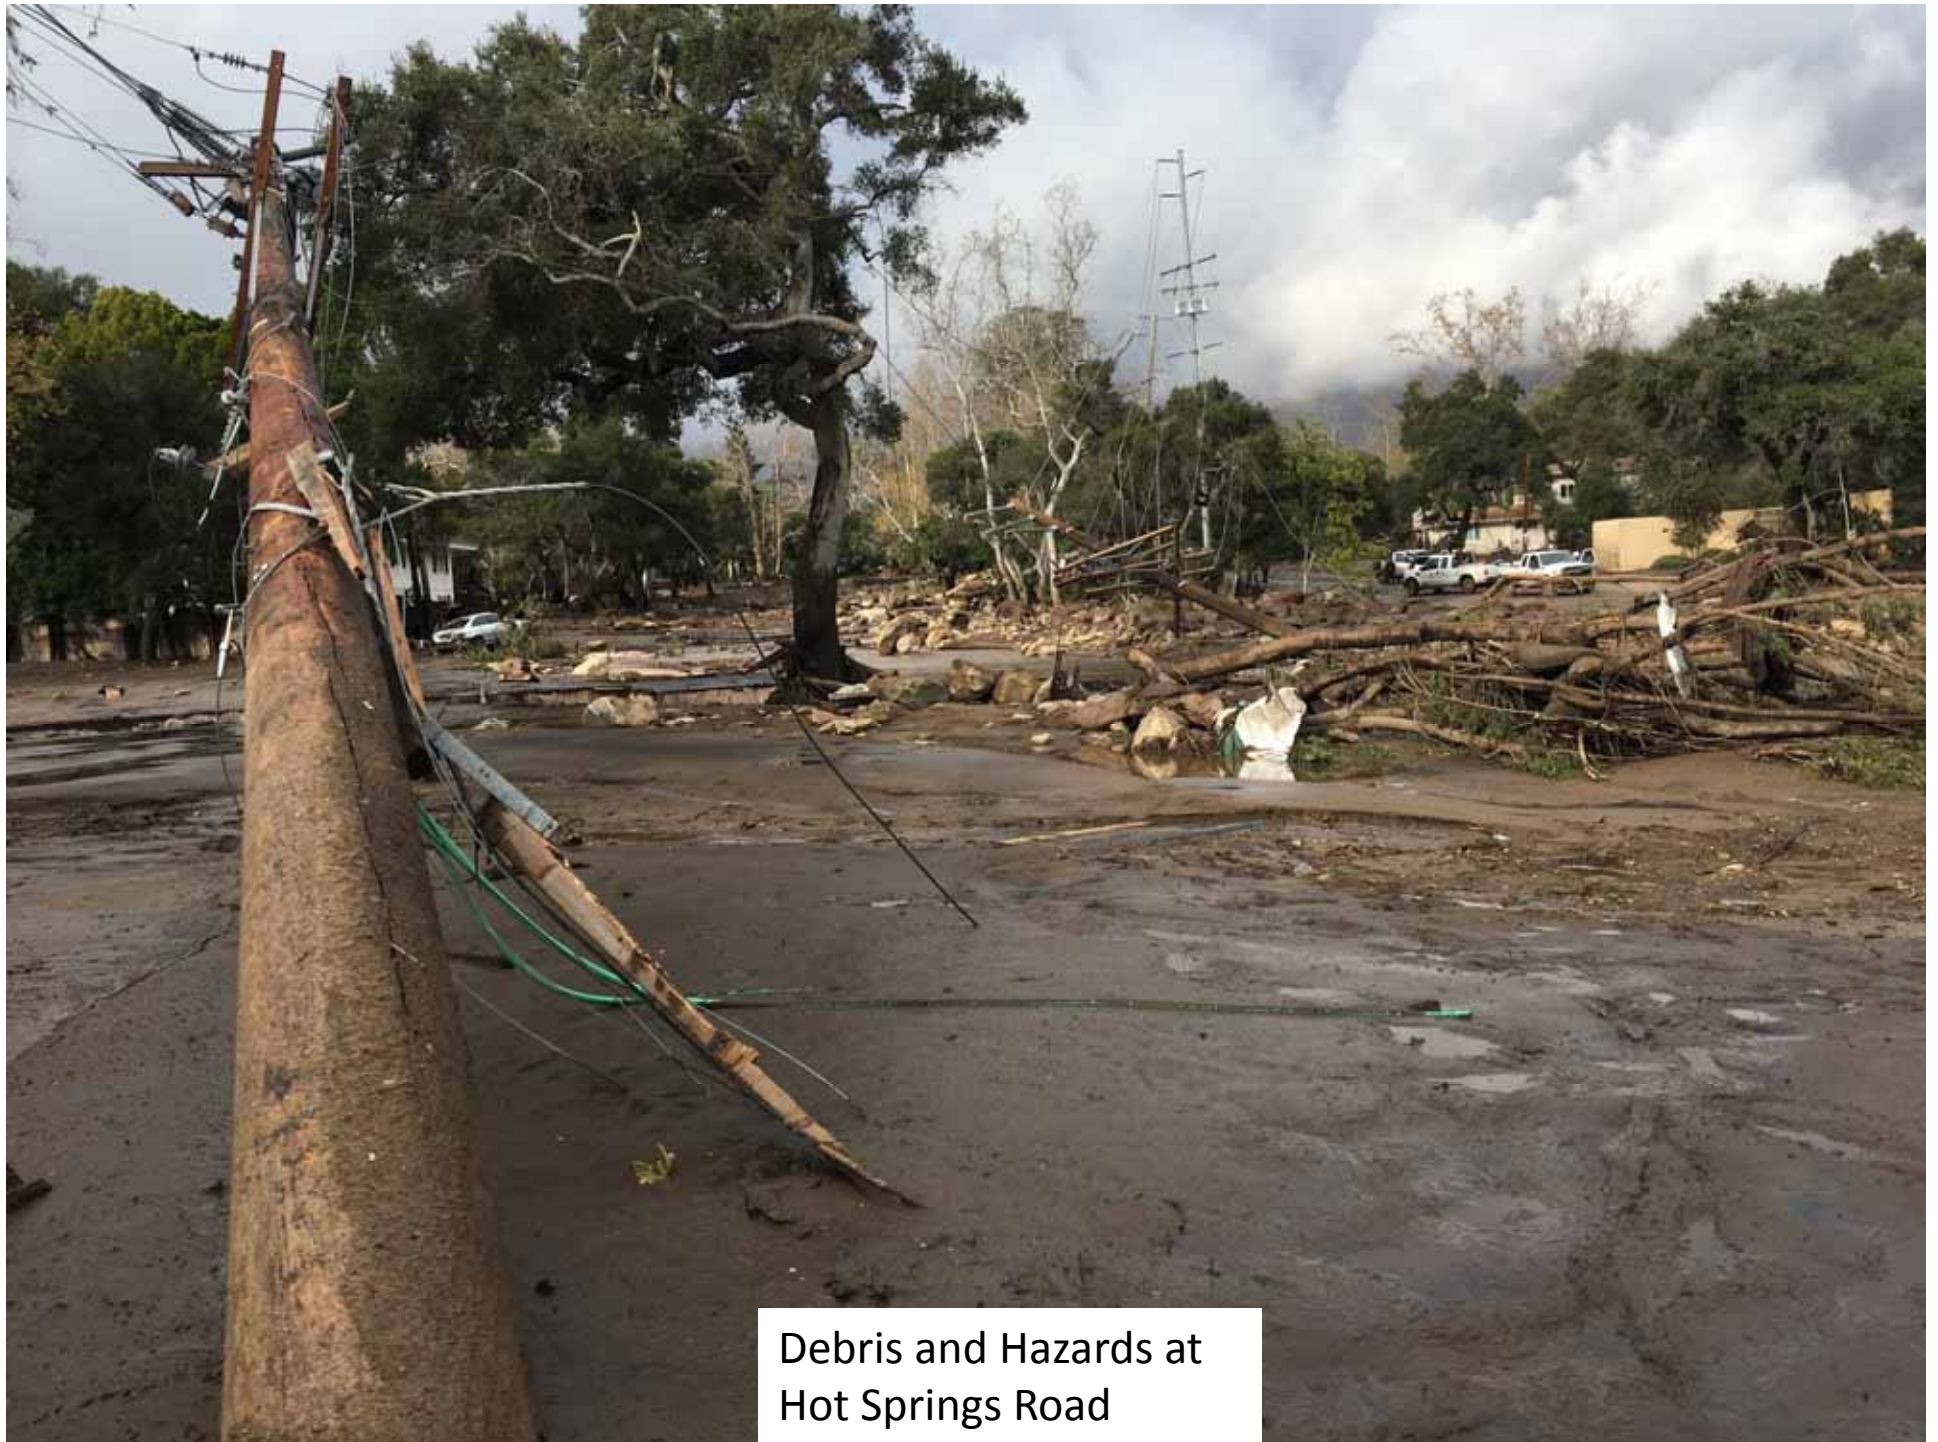
Debris and Hazards at
Hot Springs Road

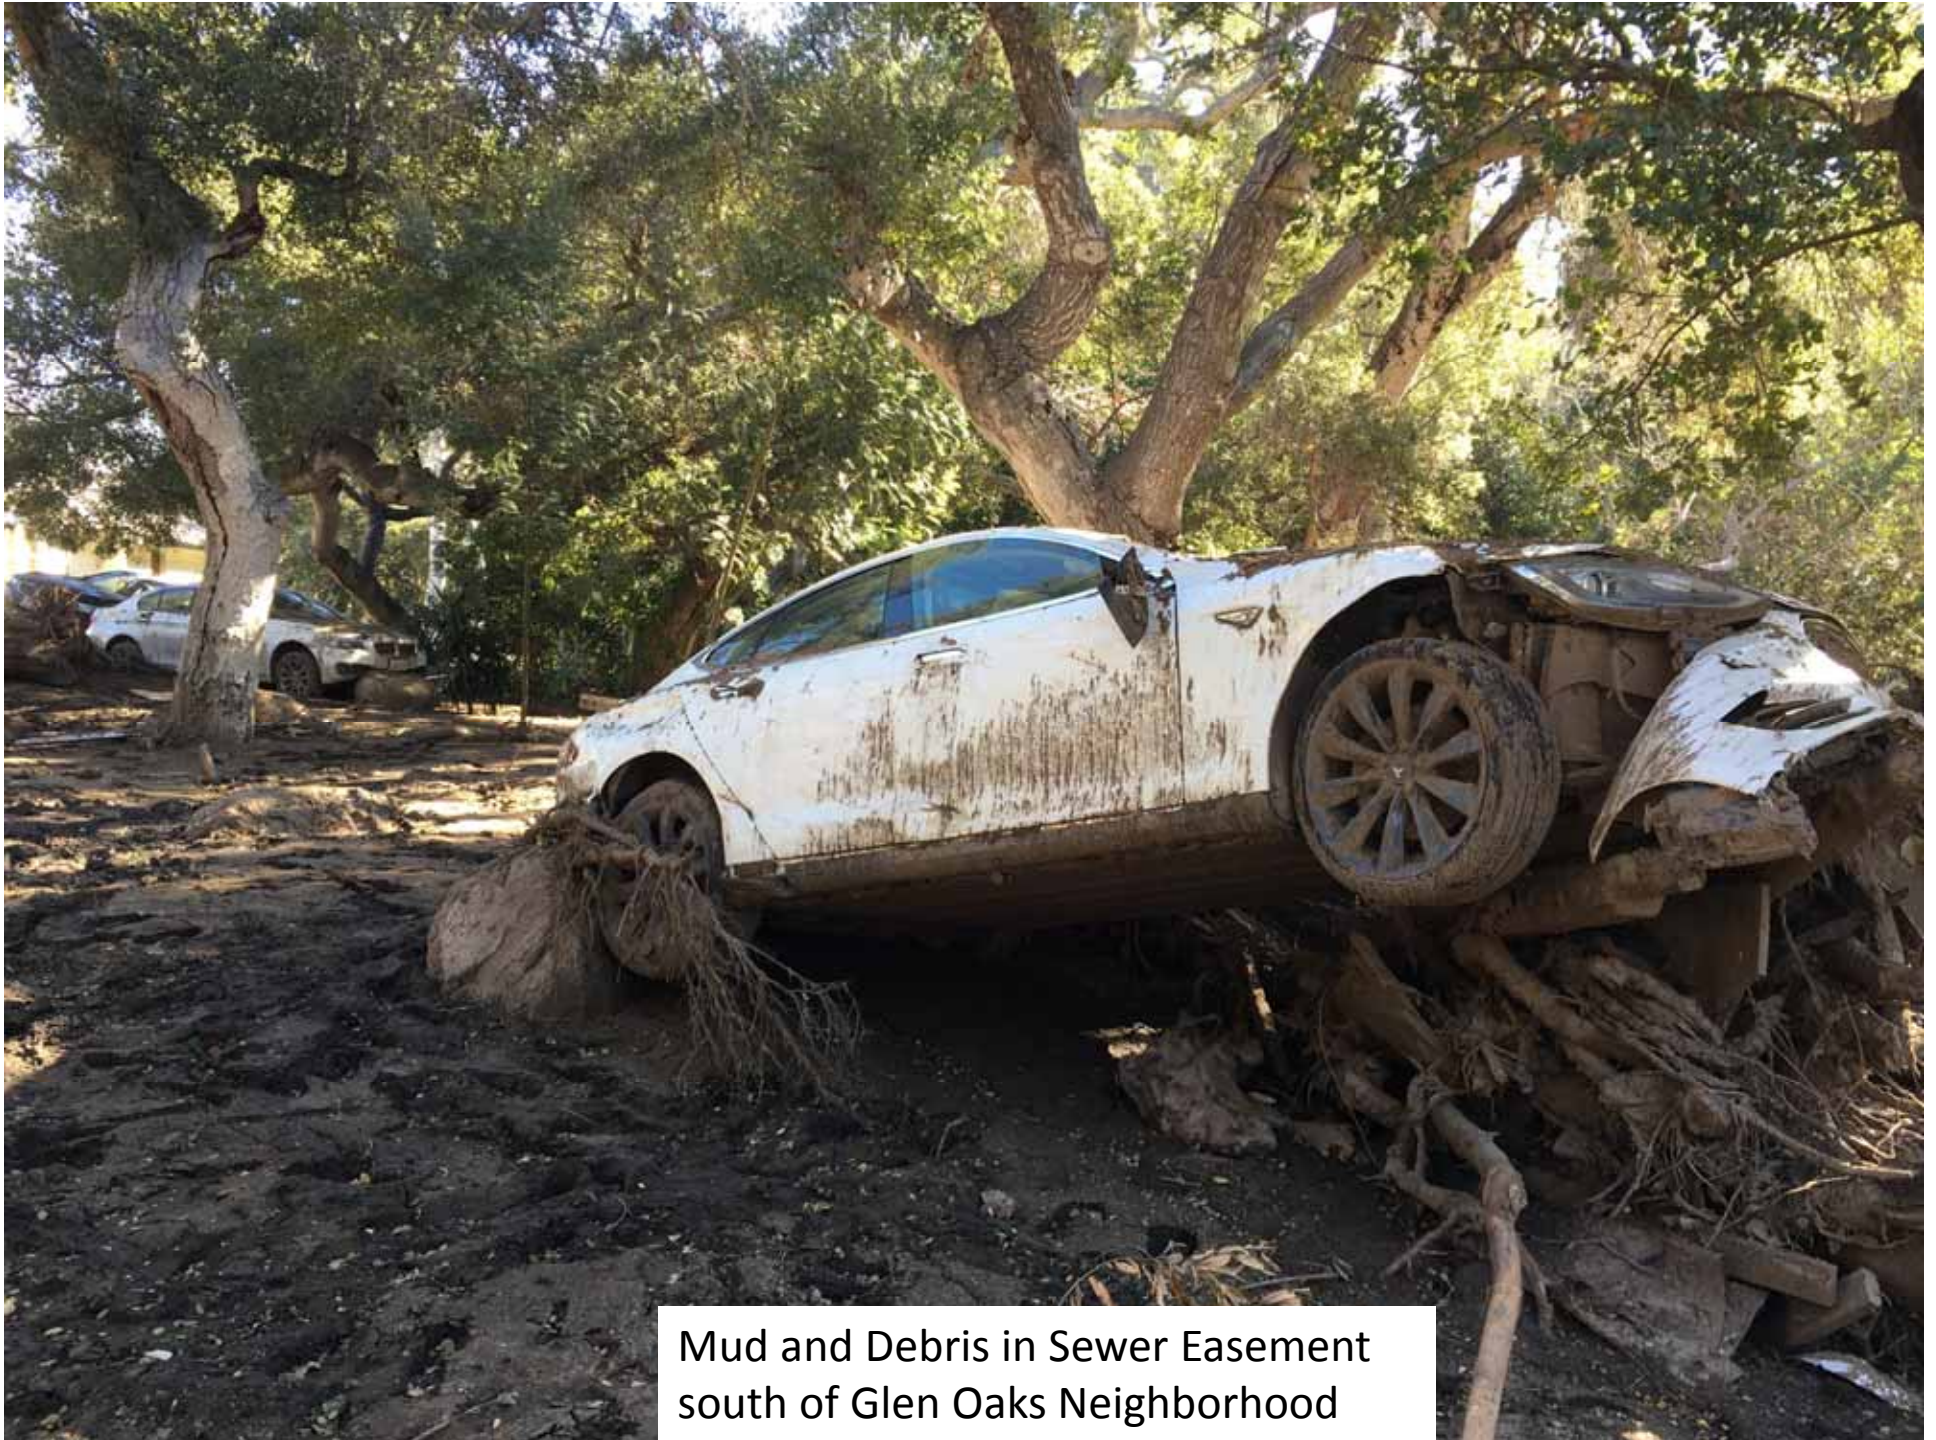
Mud and Debris in Sewer Easement south of Glen Oaks Neighborhood

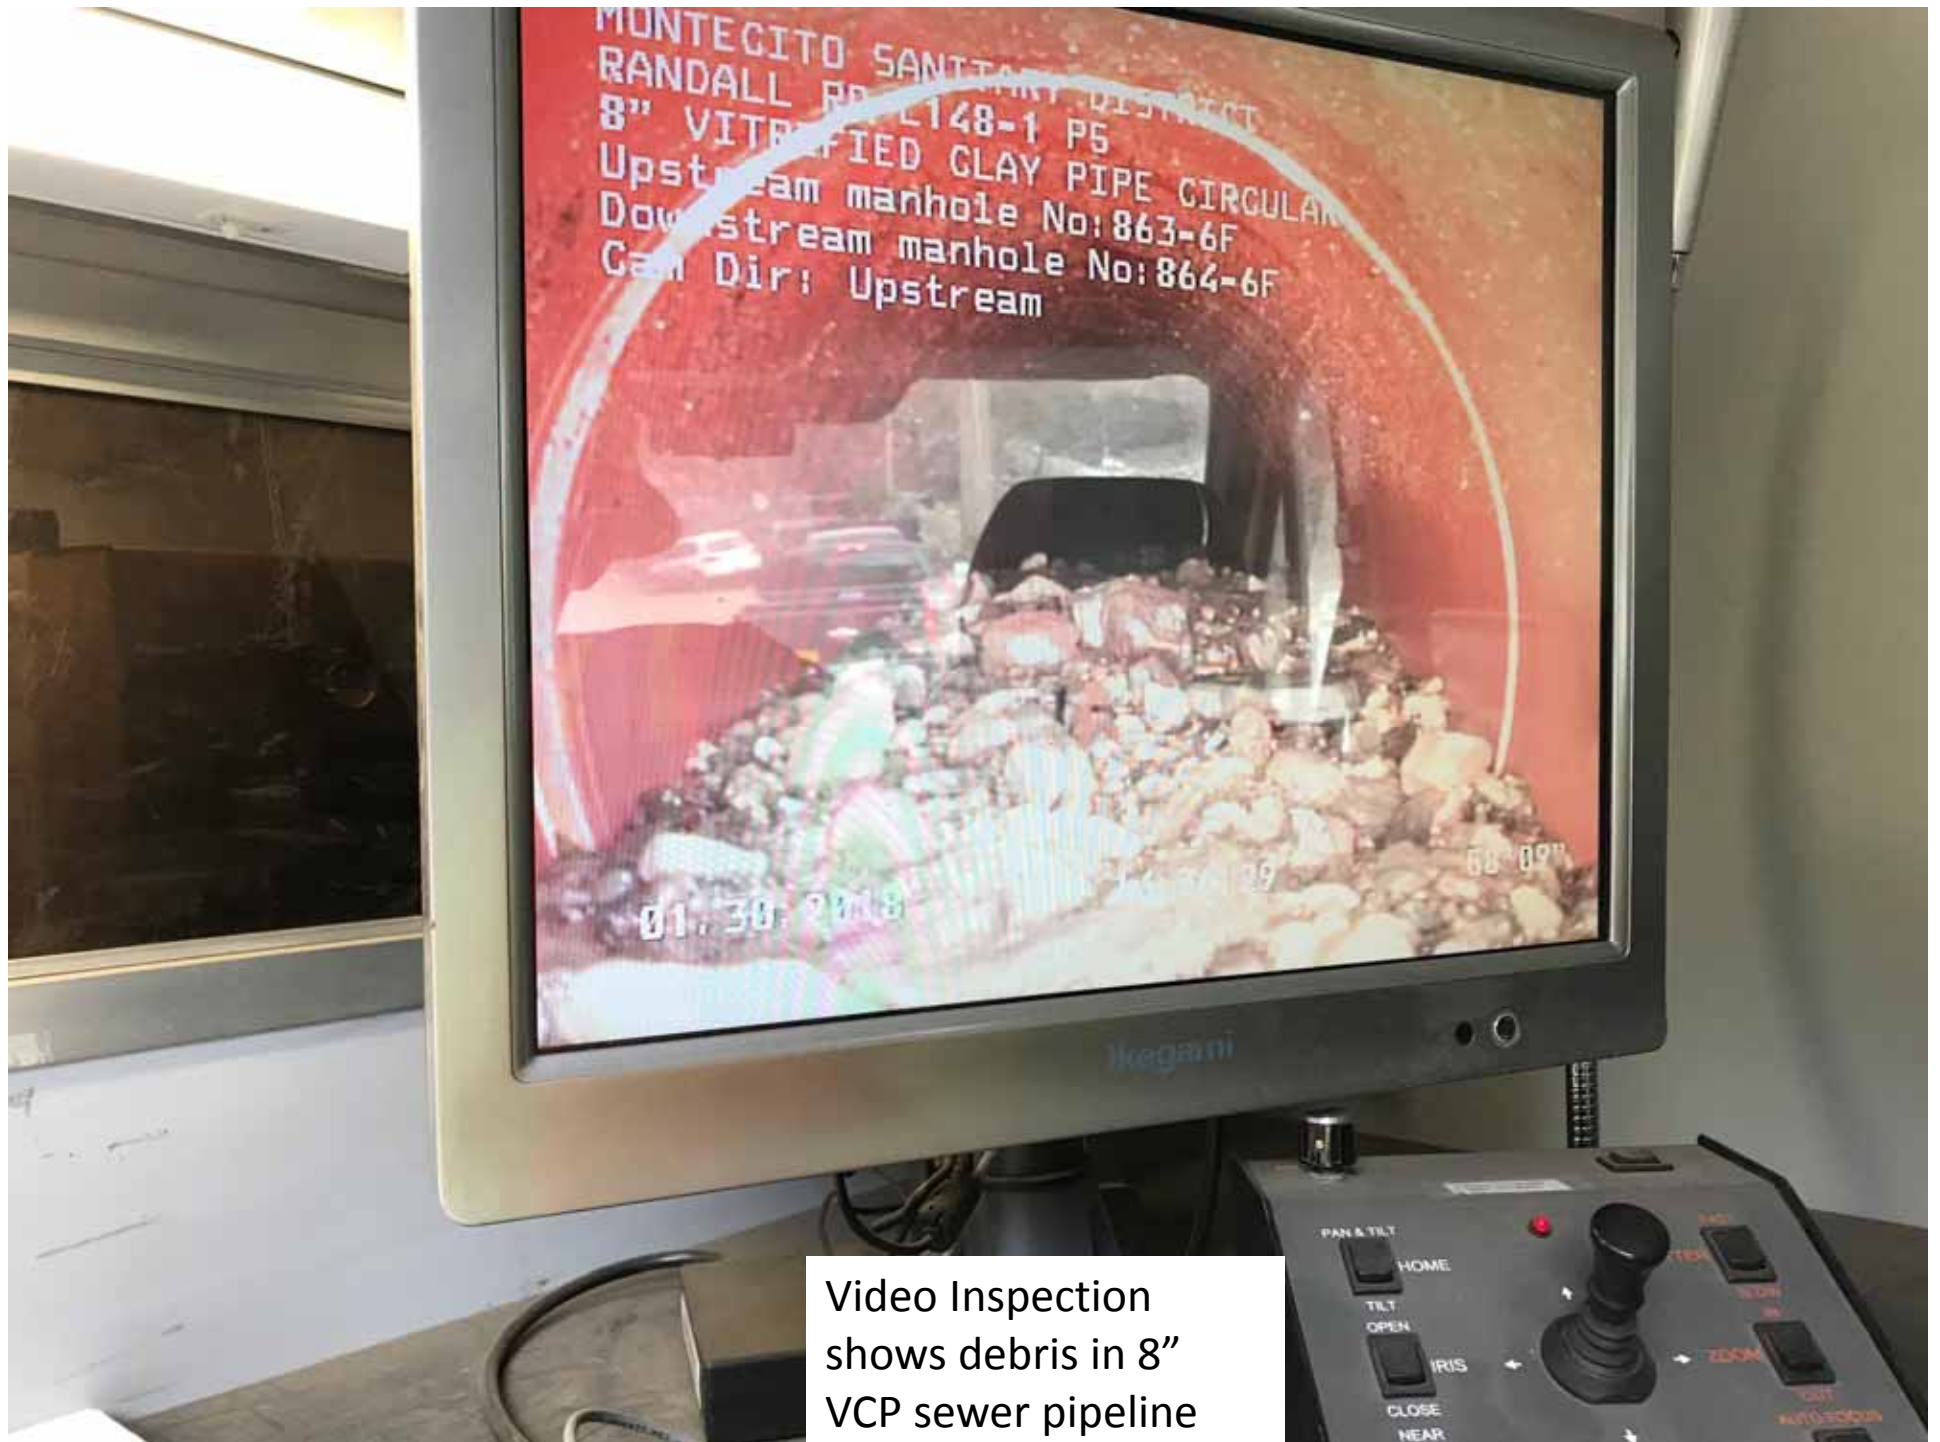
Video Inspection shows debris in 8" VCP sewer pipeline

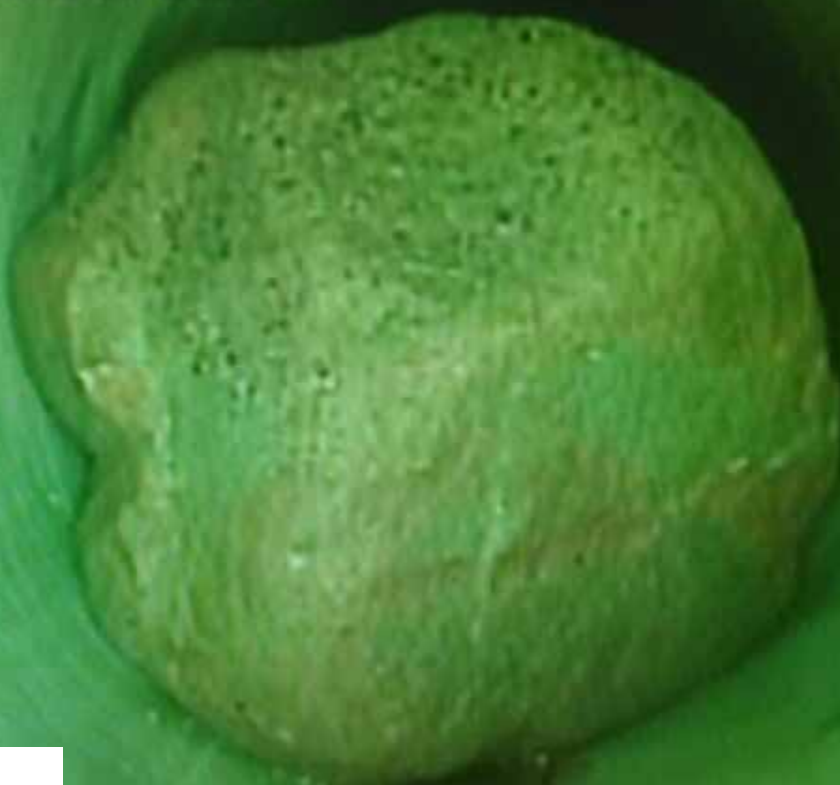
Upstream manhole No: 614-30
Downstream manhole No: 615-
Cam Dir: Downstream

Video Inspection
shows 6" rock in 8"
sewer pipeline

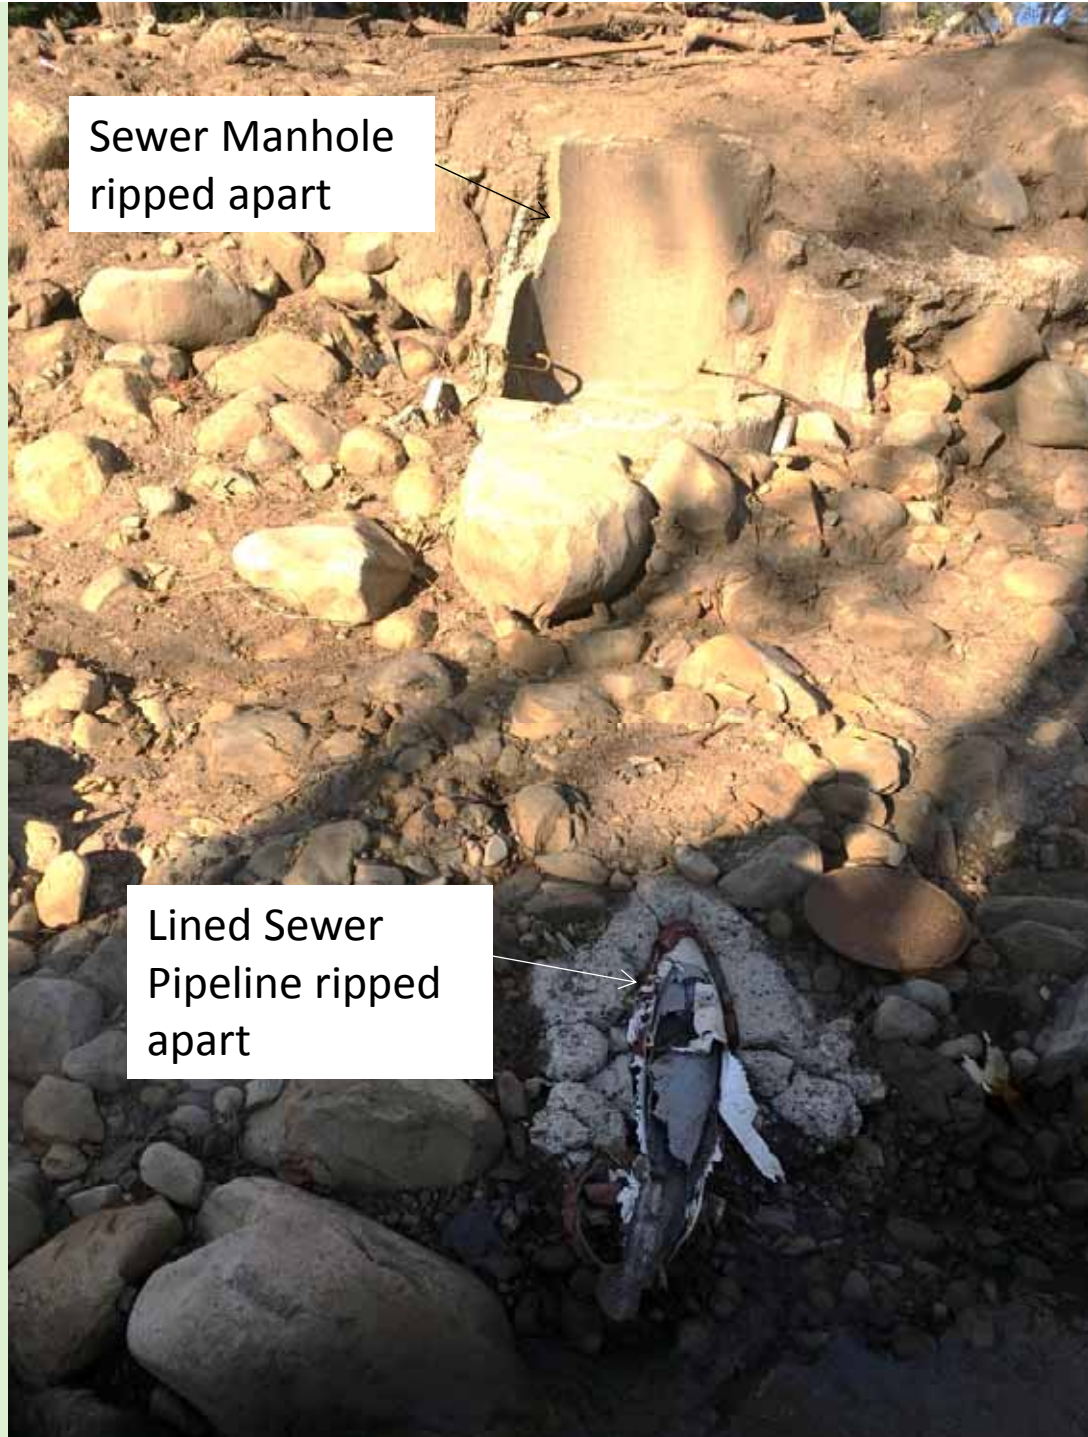
Montecito
Creek

DAMAGED
MANHOLE AND
PIPELINE

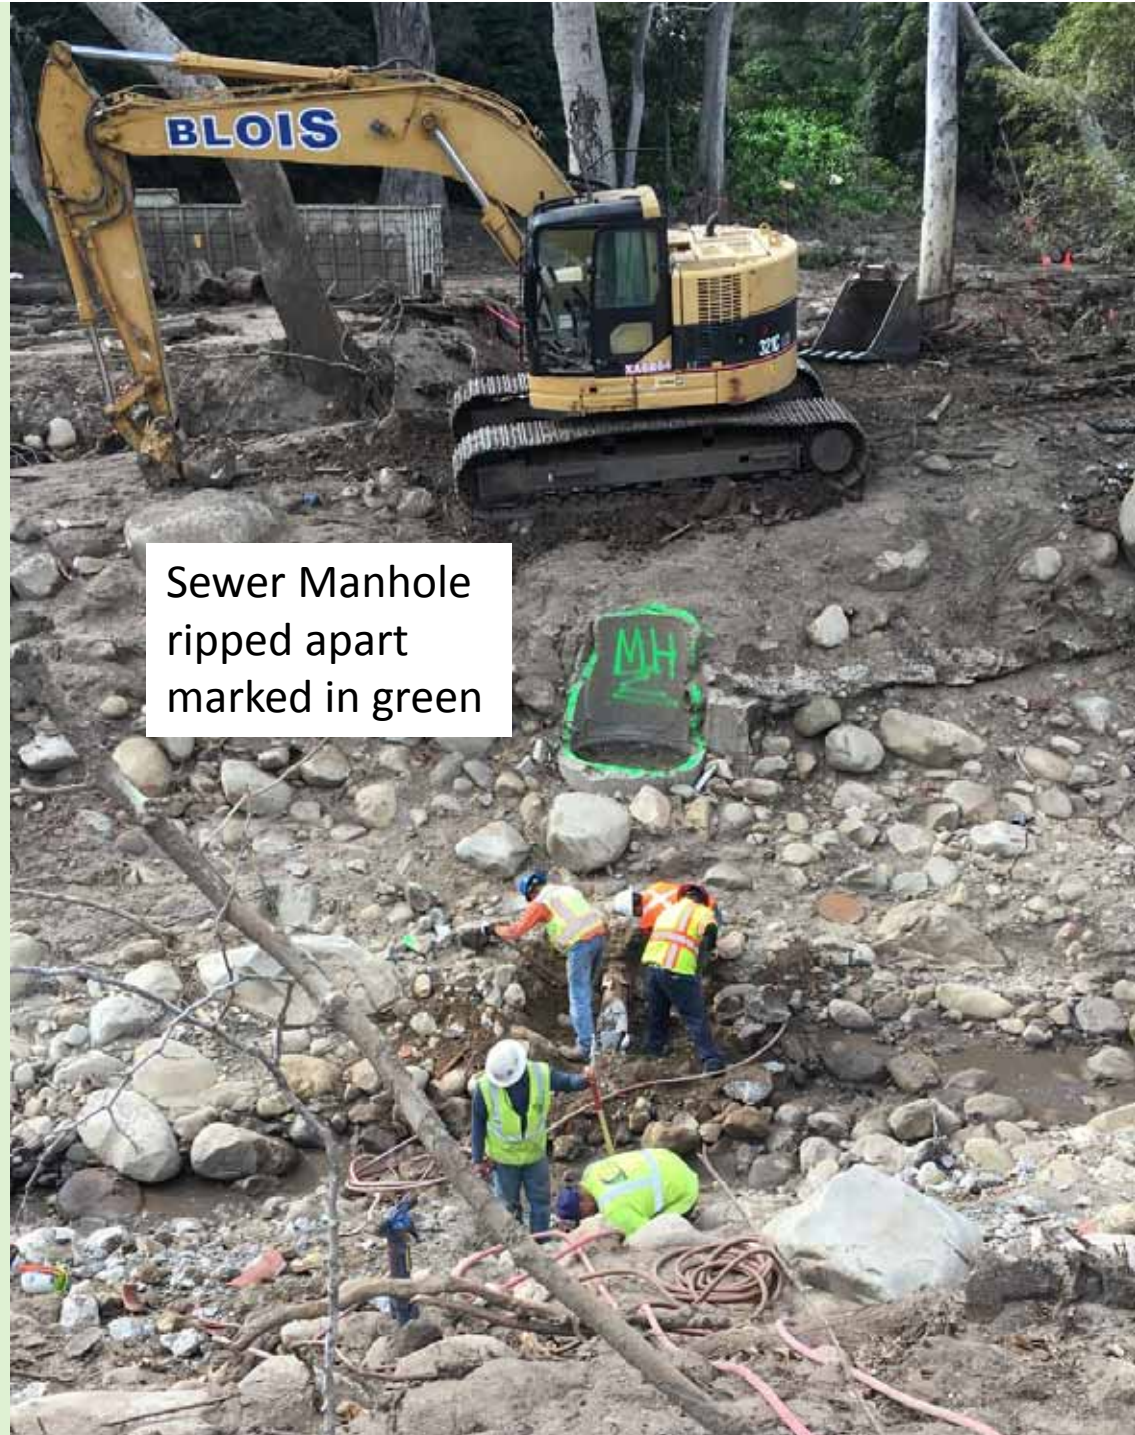
MONTECITO CREEK

Sewer Manhole
ripped apart
marked in green

Blois
Construction,
hired by MSD,
repaired sewer
pipeline and
manhole

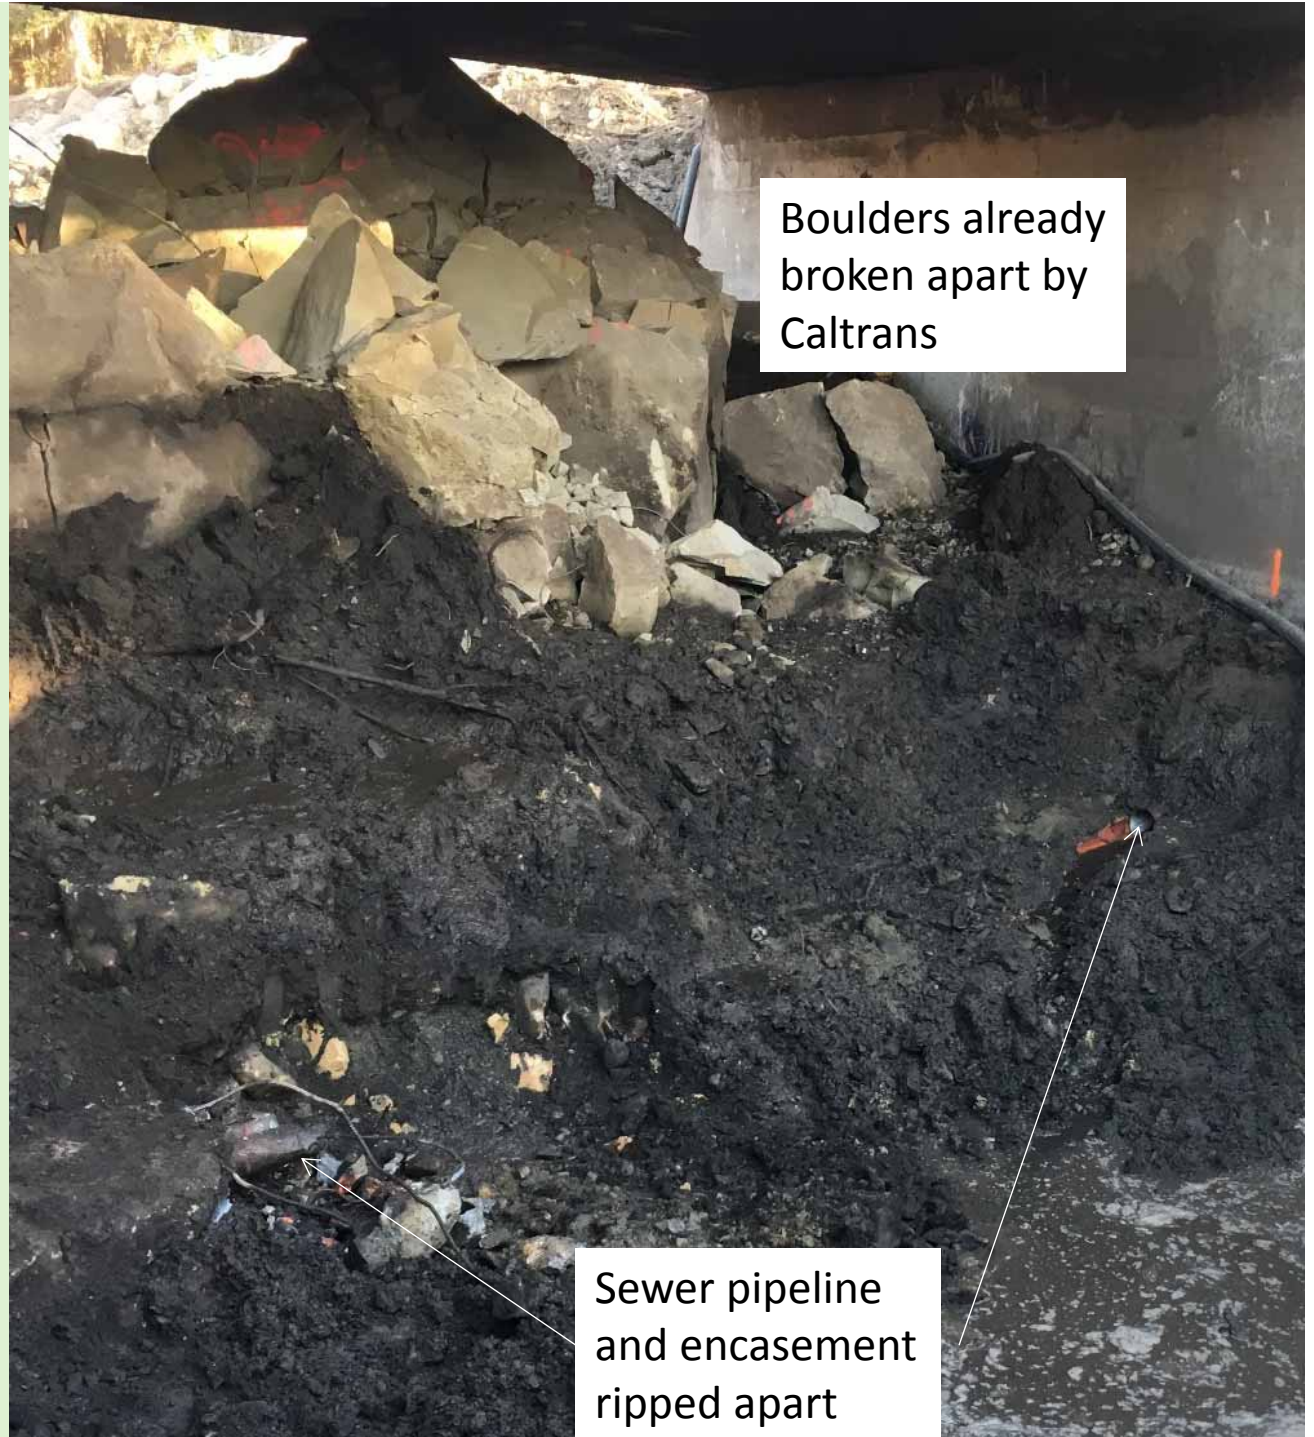
SAN YSIDRO CREEK UNDER EAST VALLEY ROAD BRIDGE

DAMAGED PIPELINE

Caltrans and County
Flood Control granted
MSD a 48 hour time
period to complete the
pipeline repairs

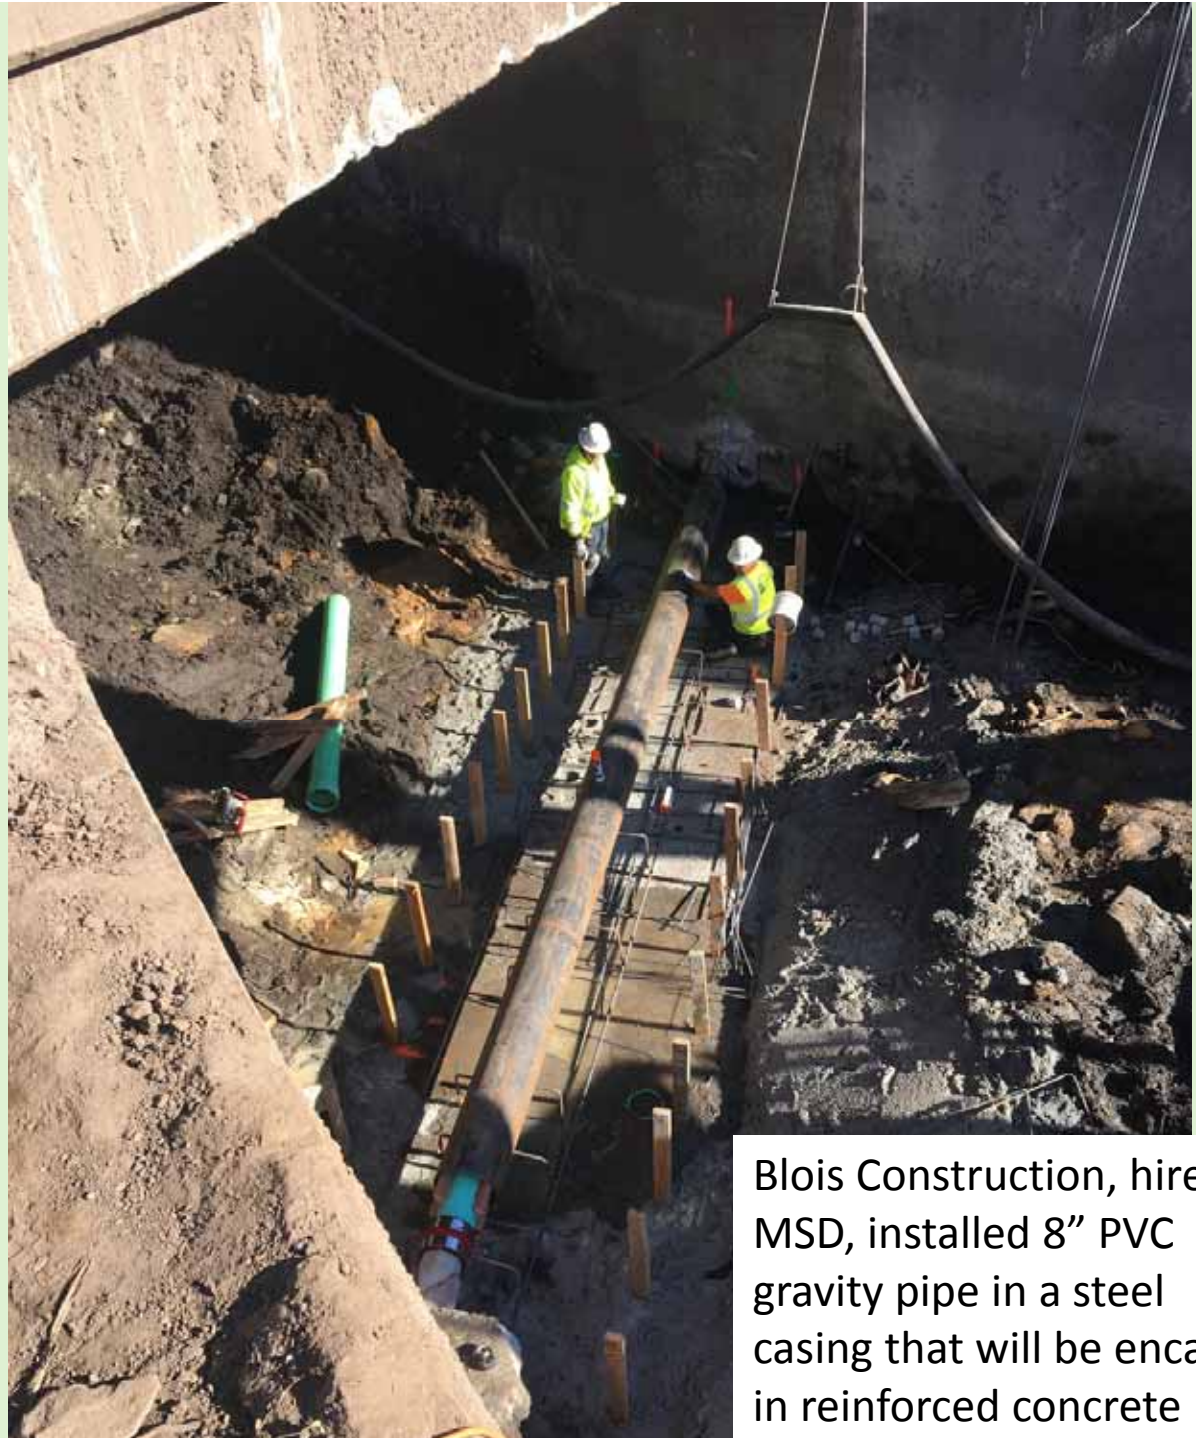
SAN YSIDRO CREEK UNDER EAST VALLEY ROAD BRIDGE

SEWER PIPE IN CASING

MSD hired Blois
Construction to
complete repairs

Blois Construction, hired by MSD, installed 8" PVC gravity pipe in a steel casing that will be encased in reinforced concrete
