Montecito Sanitary District's Response to the Thomas Fire 1/9 Debris Flow Event

July 17, 2018

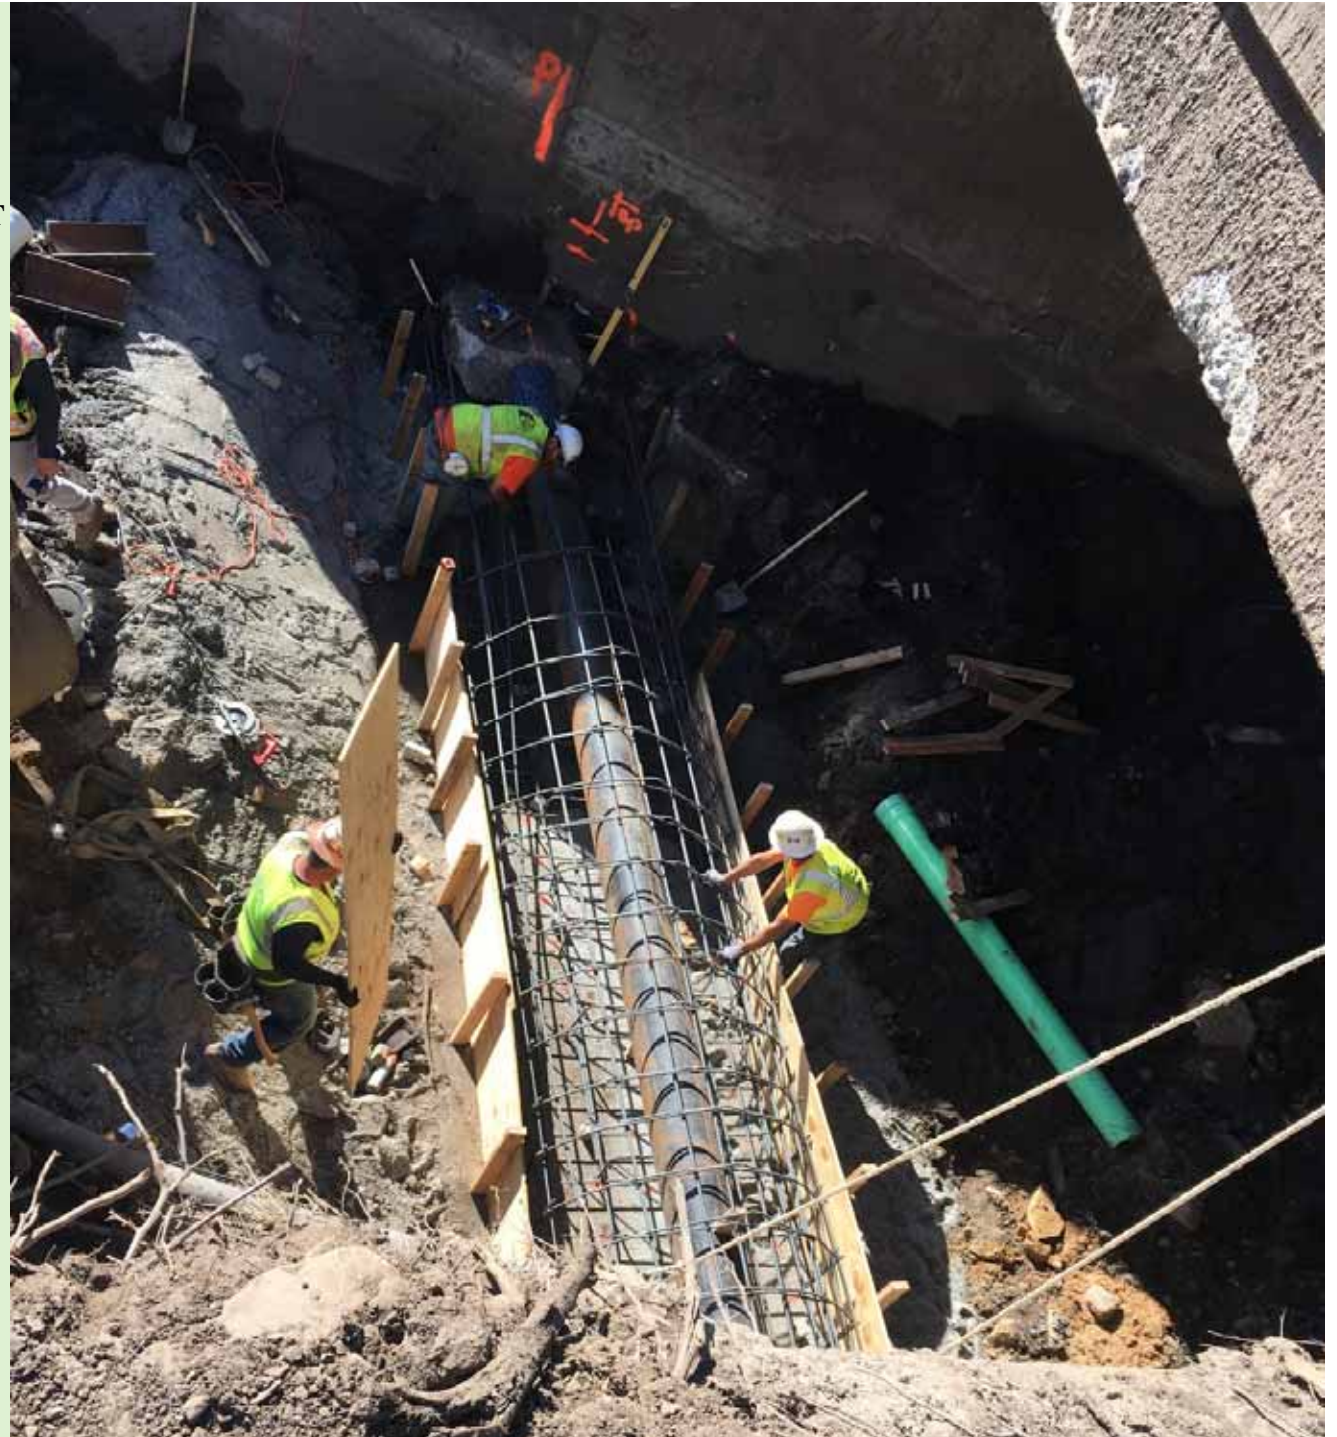
SAN YSIDRO
CREEK UNDER
EAST VALLEY
ROAD BRIDGE

REBAR FOR
CONCRETE
ENCASEMENT

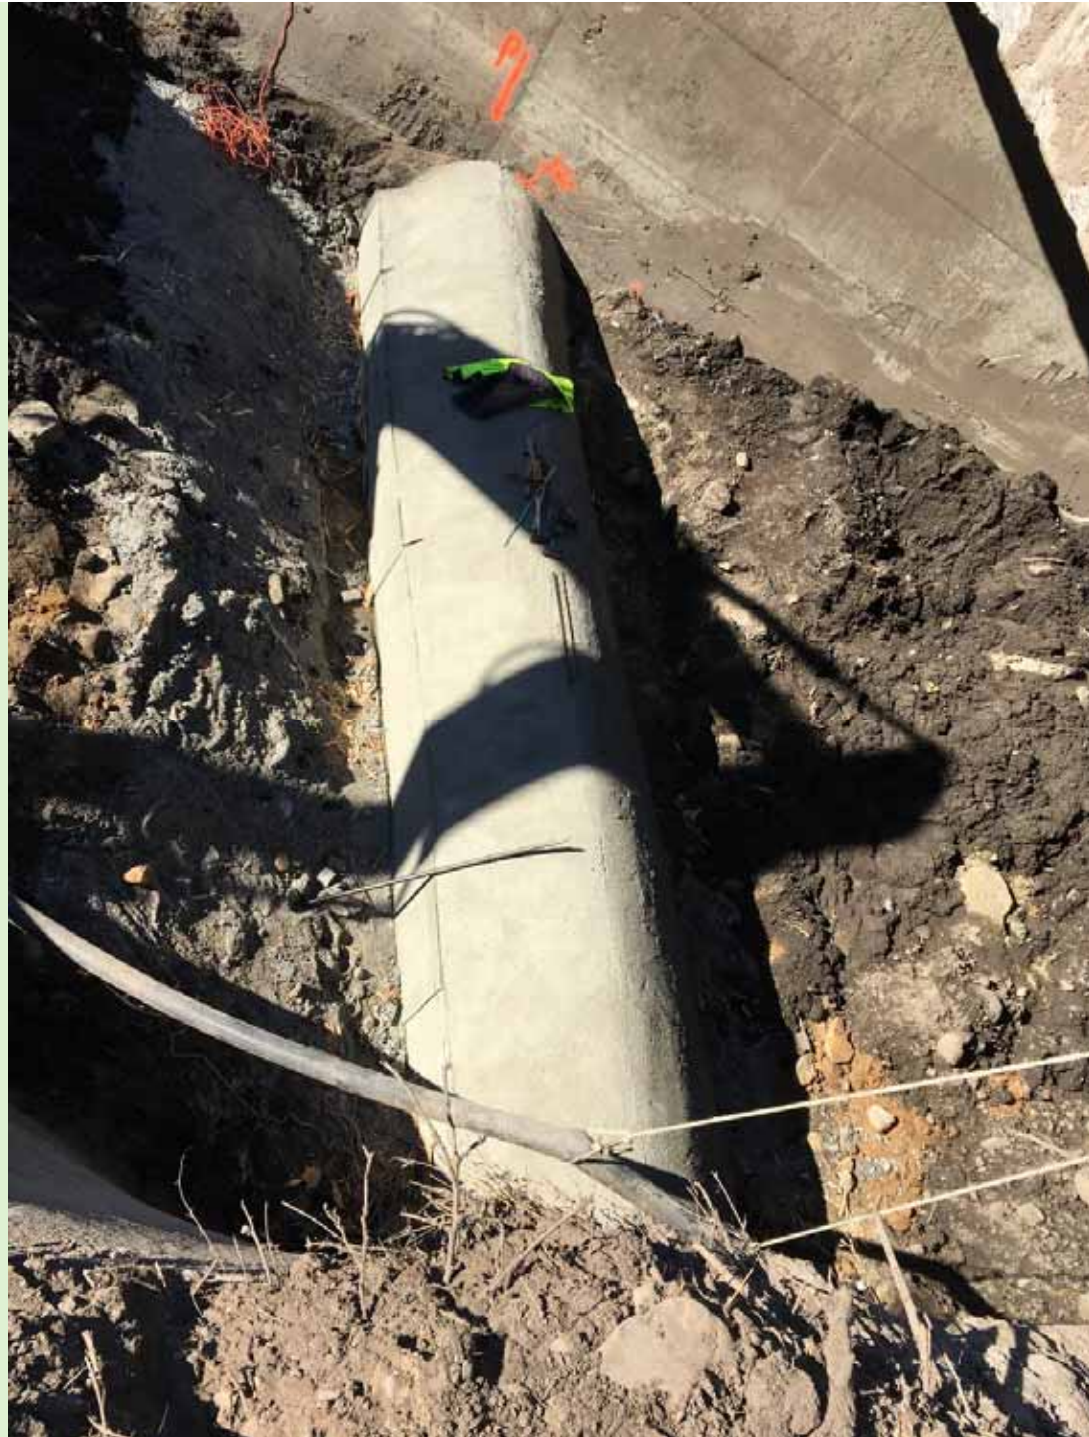
SAN YSIDRO
CREEK UNDER
EAST VALLEY
ROAD BRIDGE

CONCRETE
ENCASEMENT

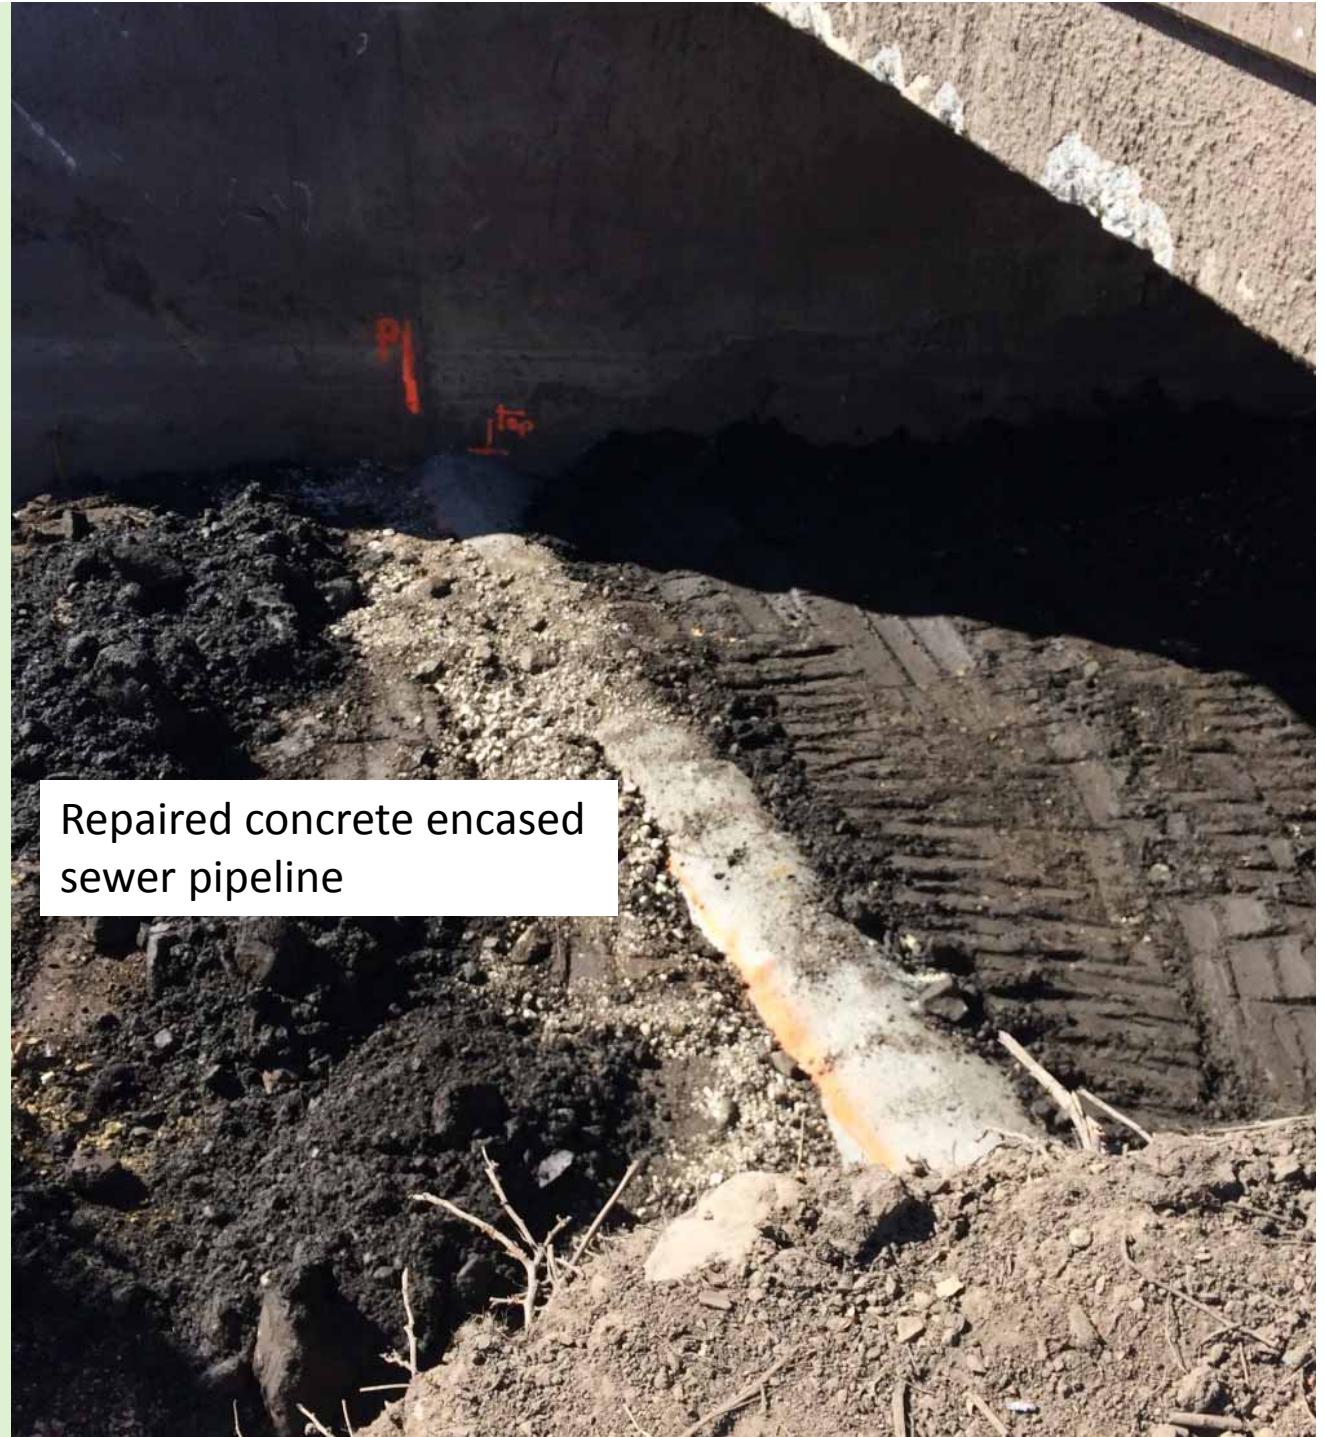
San Ysidro
Creek under
East Valley
Road Bridge

ENCASED
PIPELINE

Repaired concrete encased
sewer pipeline

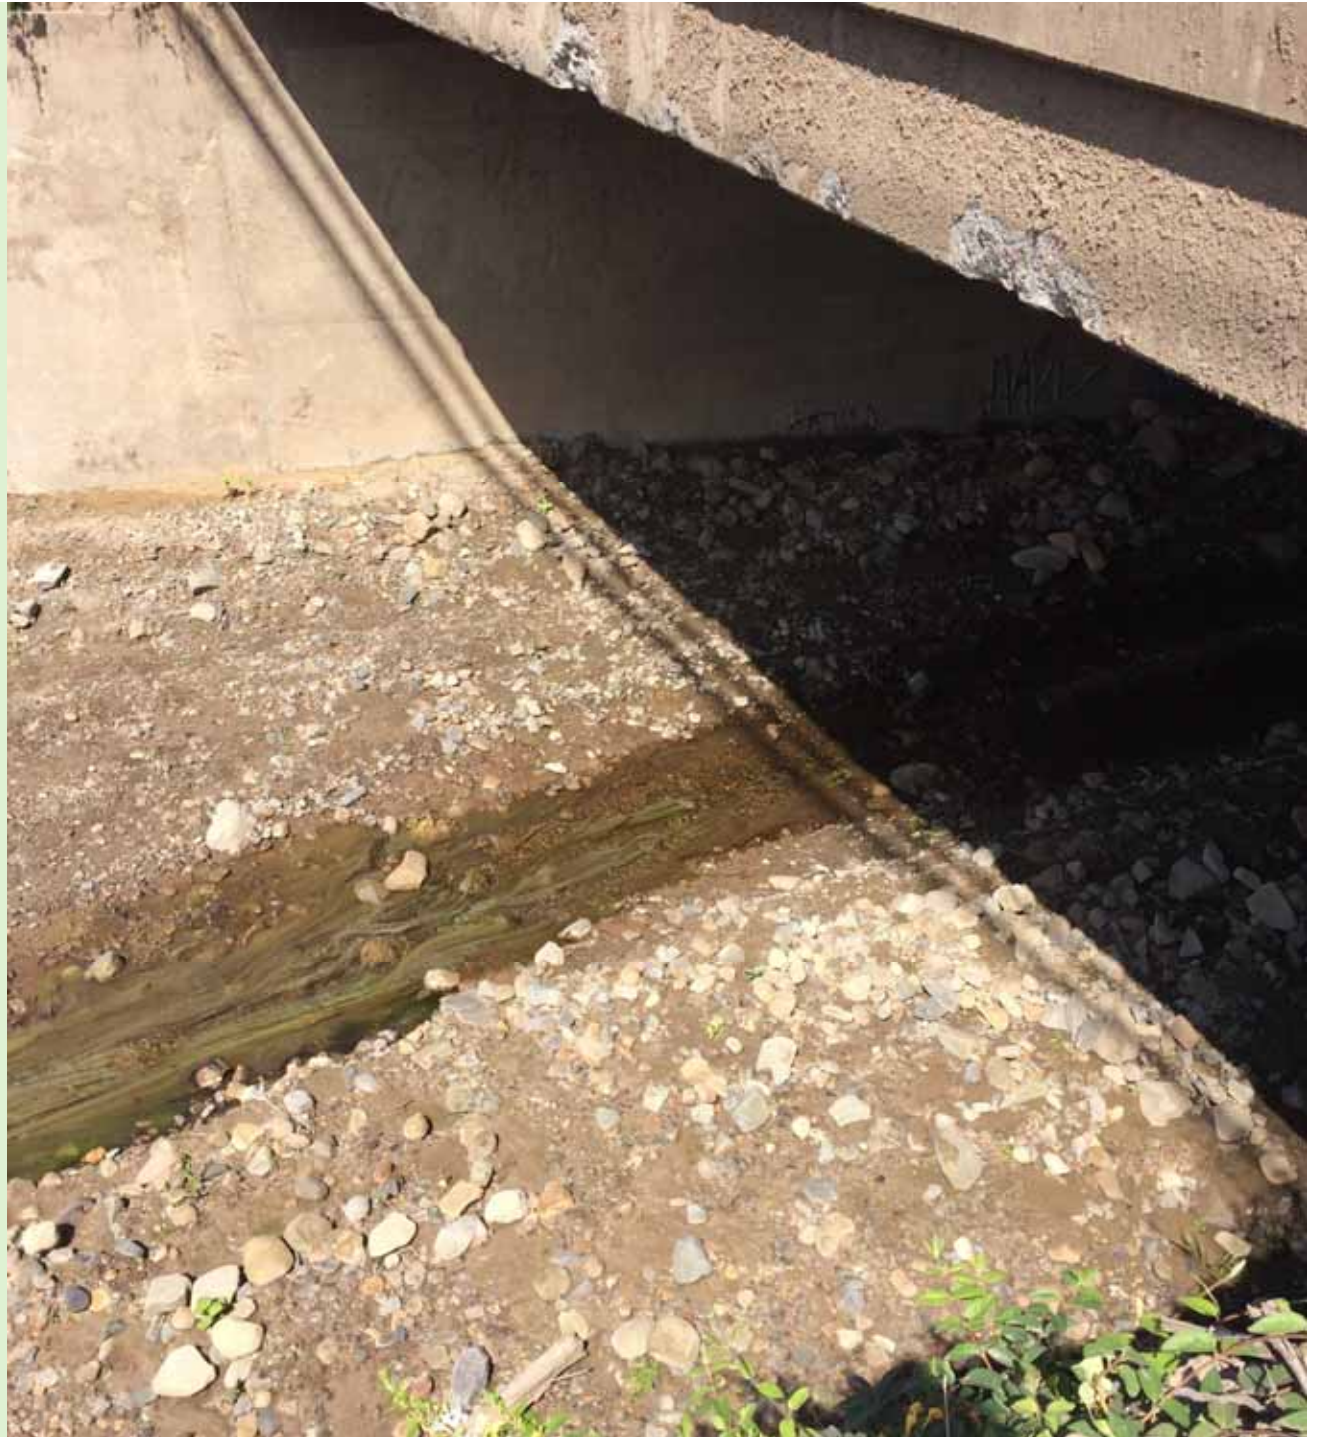
San Ysidro Creek under East Valley Road Bridge

The concrete encased
sewer pipeline is below
the natural creek
channel

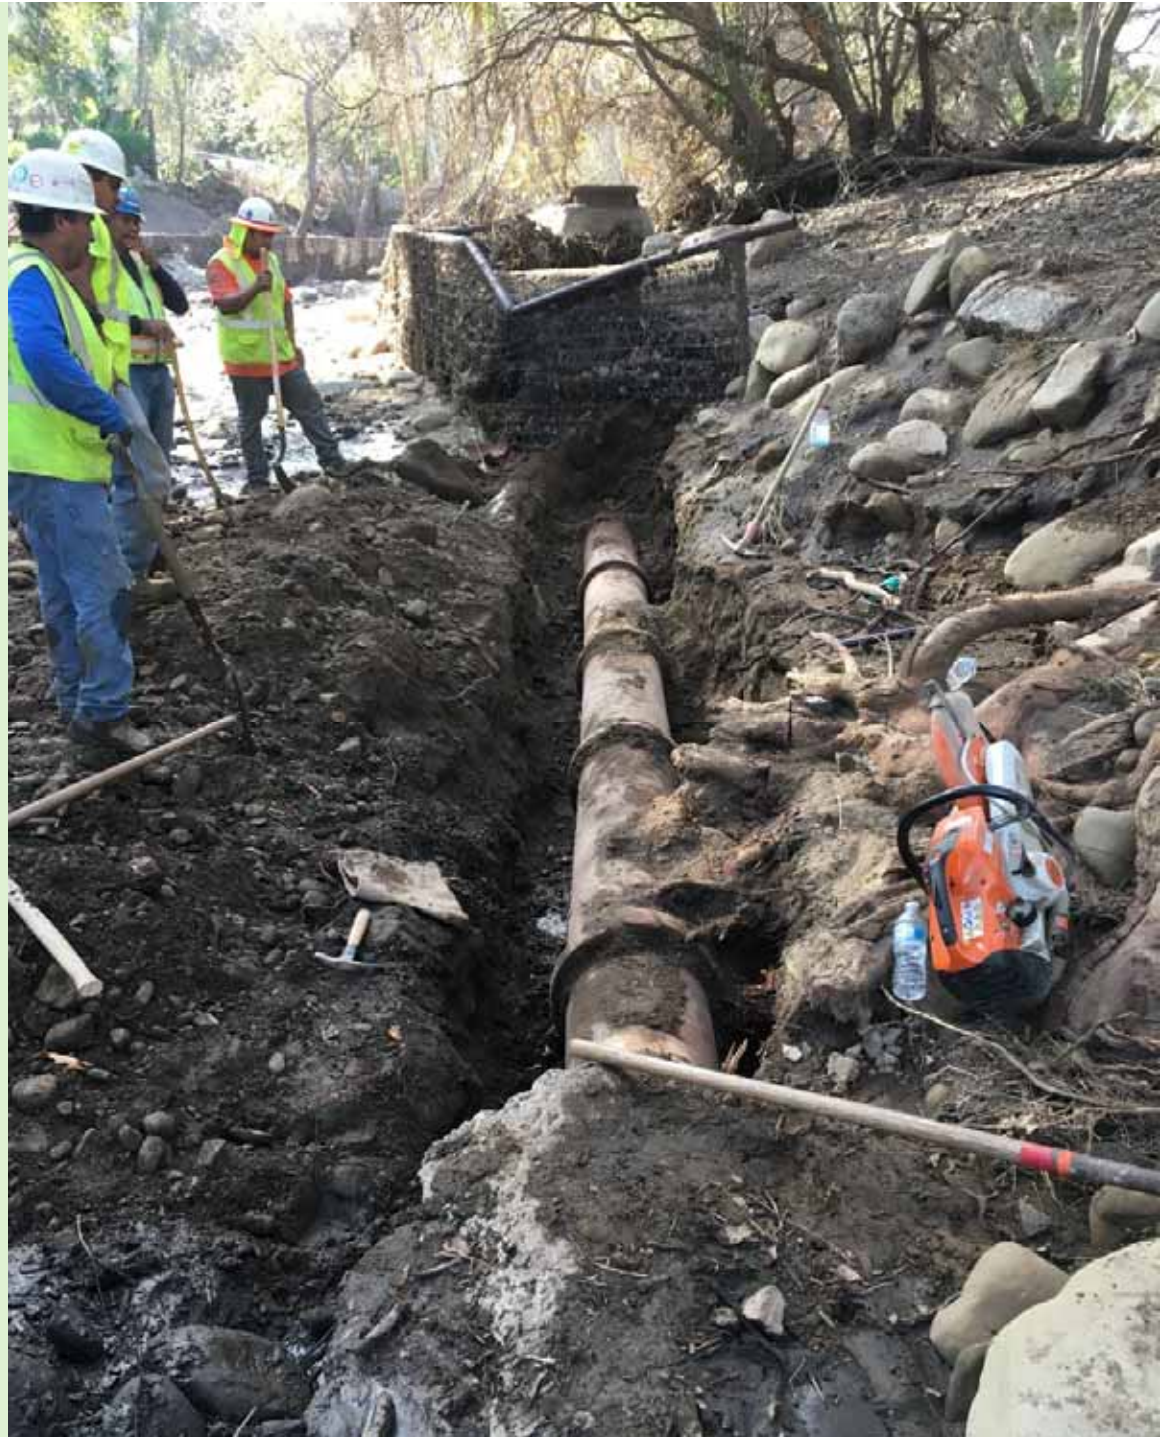
ROMERO CREEK

DAMAGED PIPELINE

MSD hired Blois
Construction to repair
the damaged concrete
encasement surrounding
the sewer main

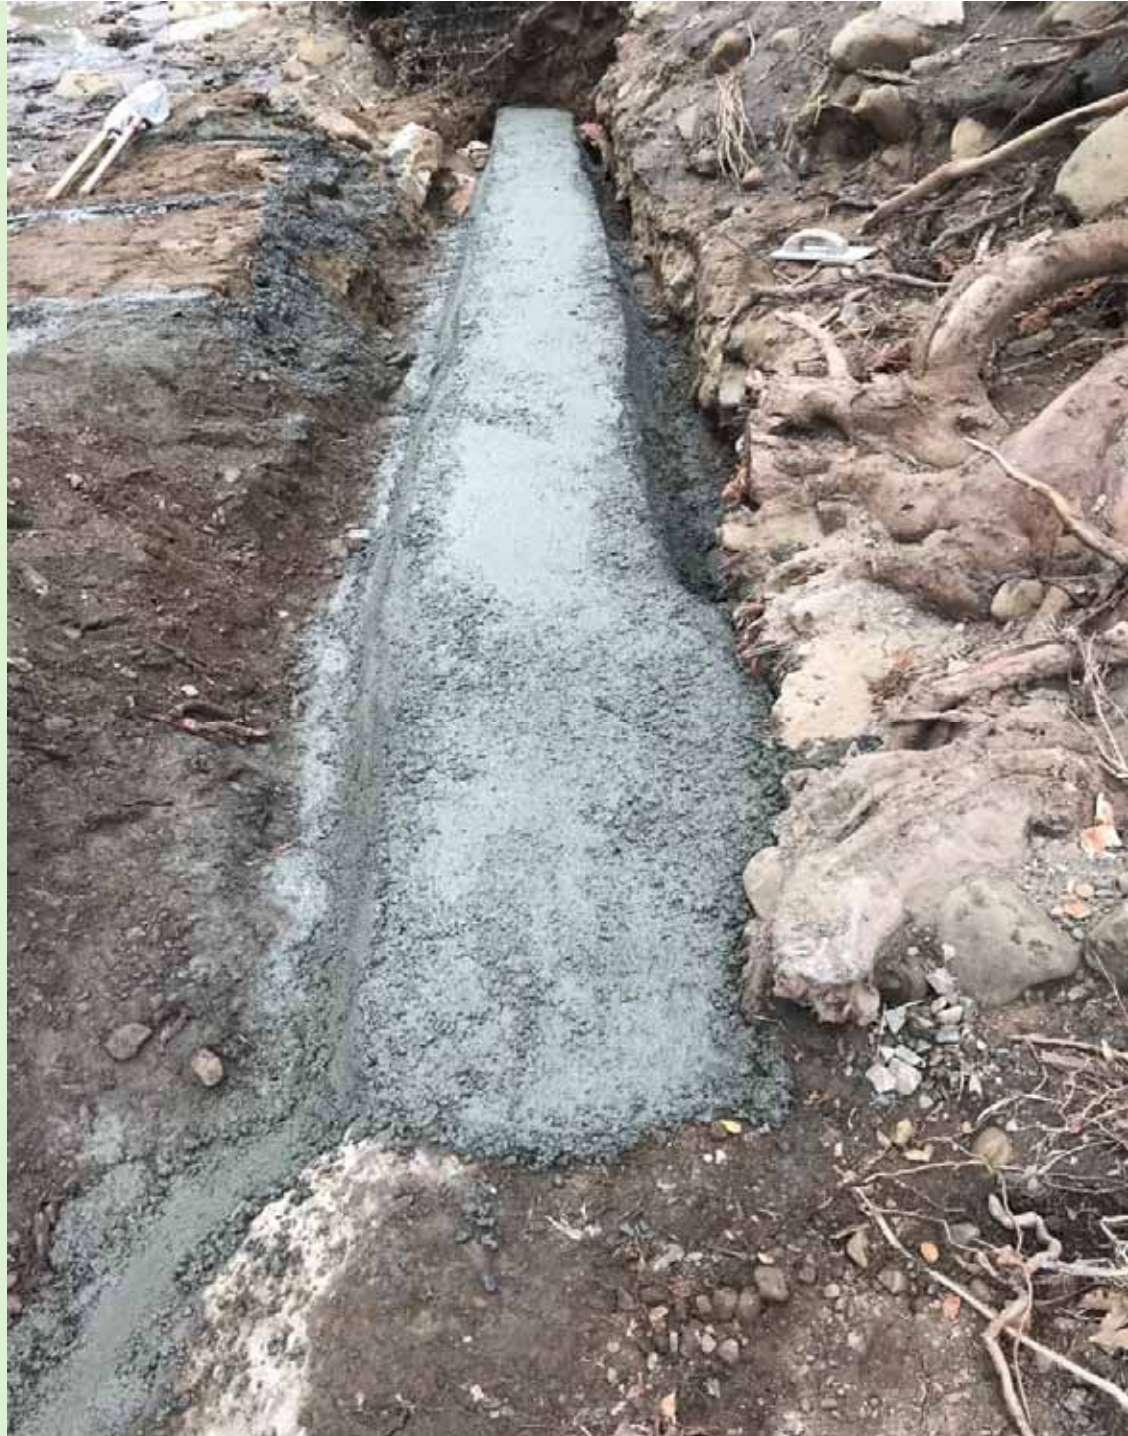
ROMERO CREEK

REPAIRED PIPELINE AND ENCASEMENT

Blois Construction
repaired the damaged
concrete encasement
surrounding the sewer
main

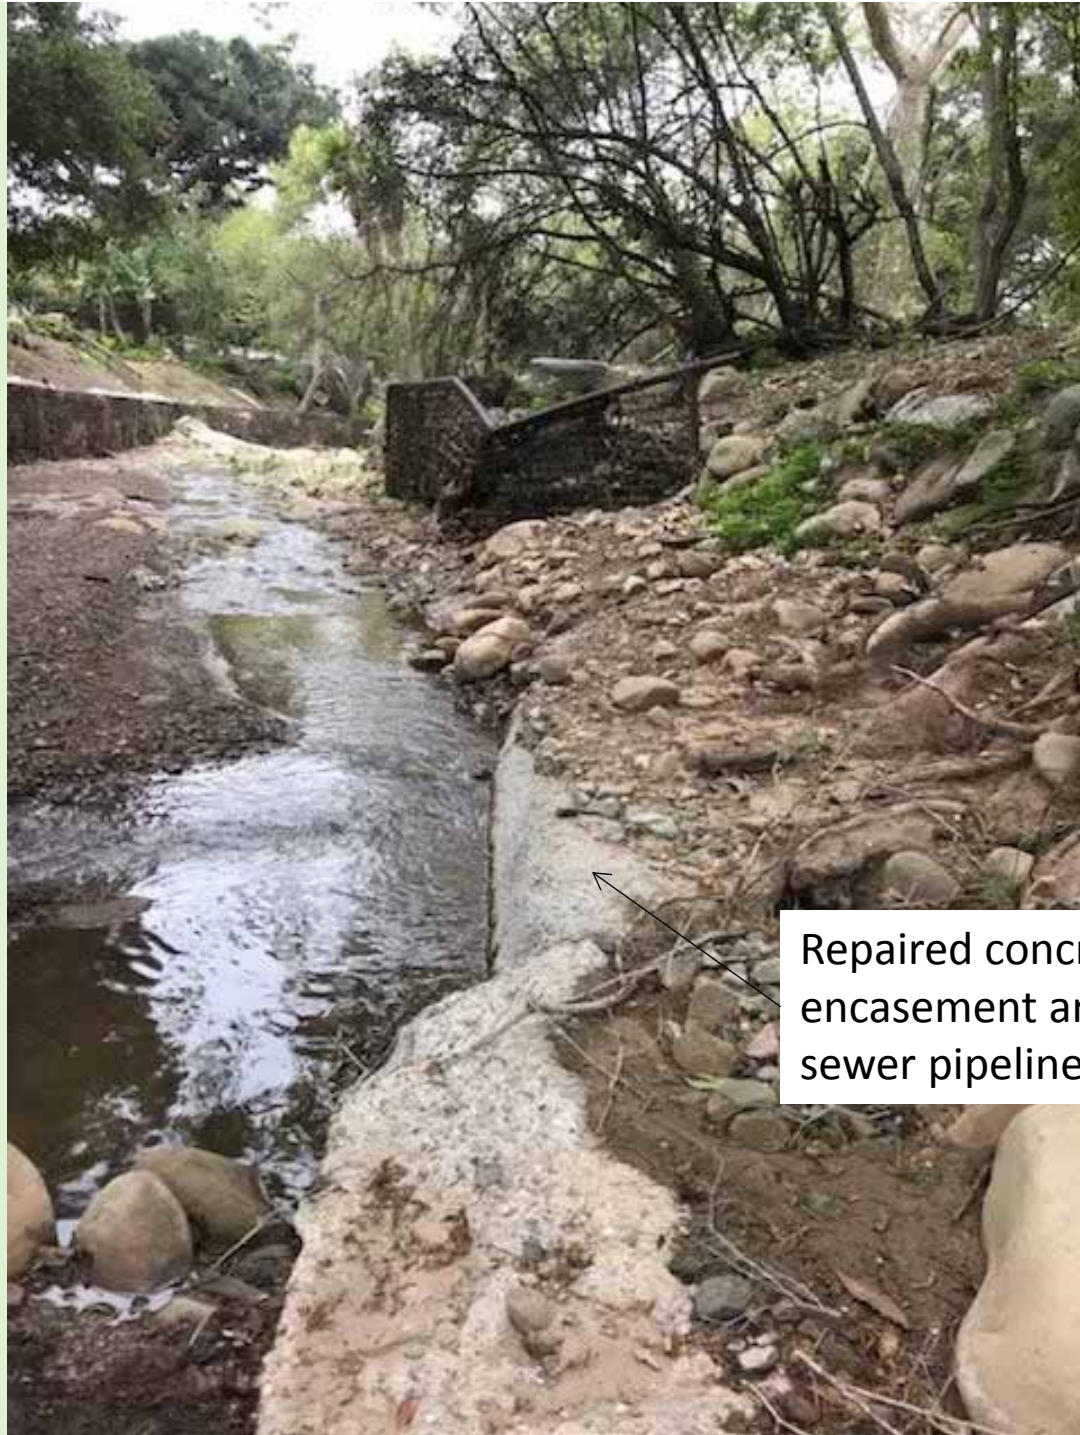
ROMERO
CREEK

ENCASED
PIPELINE

Repaired concrete
encasement around
sewer pipeline
