MONTECITO SANITARY DISTRICT

2020 ANNUAL SUMMARY REPORT

NPDES No. CA0047899

Annual Ocean Outfall Diver Survey Report

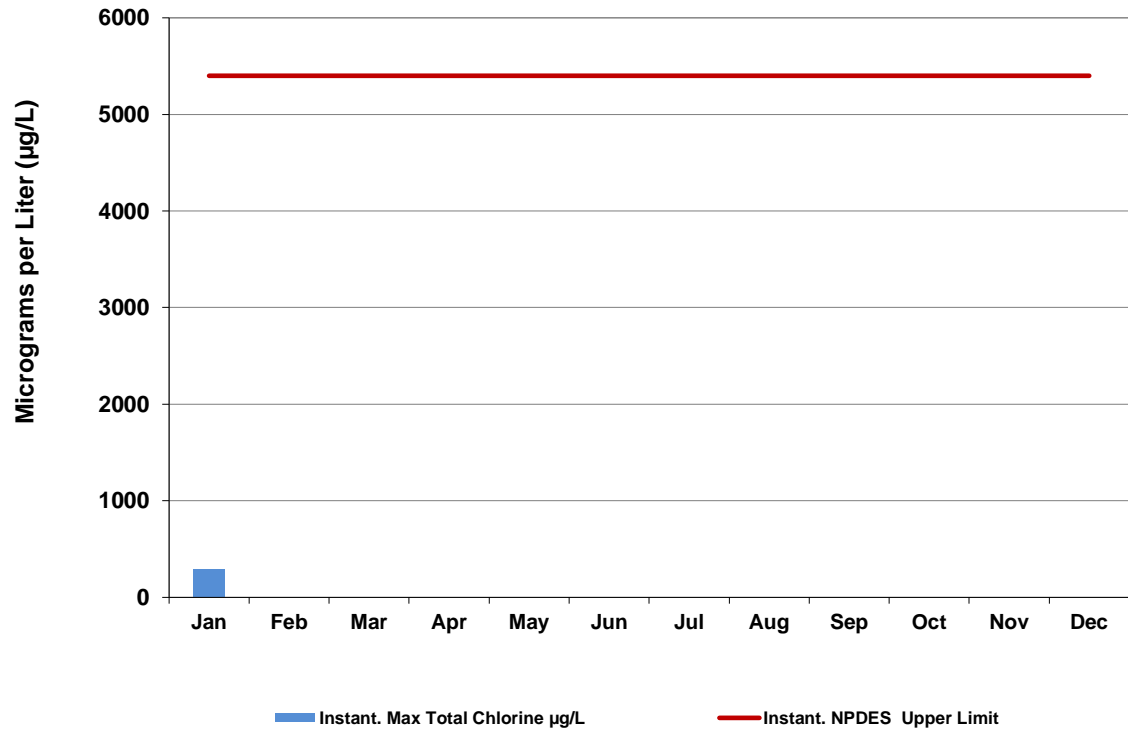
FINAL EFFLUENT
Total Chlorine Residual - Instantaneous Max (Meter)
2020

Month	NPDES Instant. Upper Limit µg/L	Instant. Max Total Chlorine µg/L
Jan	5400	288
Feb		0
Mar		0
Apr		0
May		0
Jun		0
Jul		0
Aug		0
Sep		0
Oct		0
Nov		0
Dec		0

*Higher total chlorine residual due to chlorine feed pump malfunction.

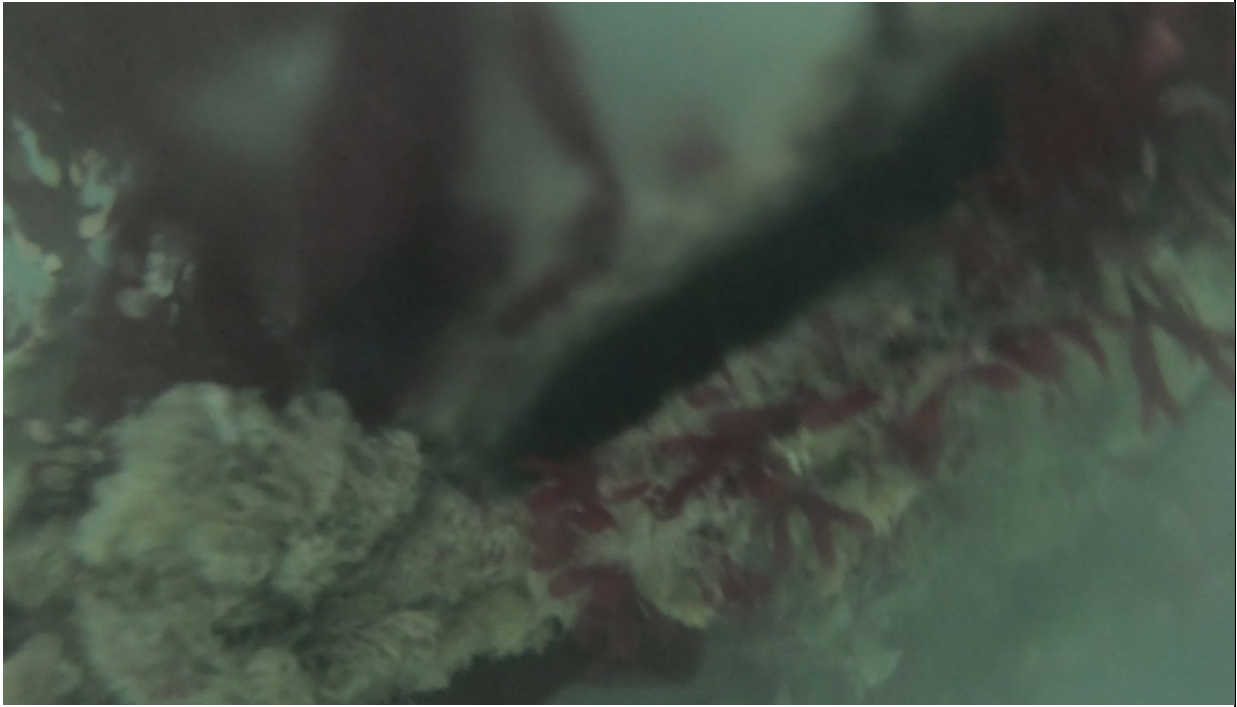
Port No. 1

each lateral port of the diffuser section was filmed. The end cap of the outfall was partially buried, however the end cap was in place. The Tideflex rubber valves located on each of the ten diffuser ports were functioning properly and the port openings were 1/16th inch. The lateral and terminal ports showed considerable biological growth surrounding each port, however this growth did not appear to disrupt flow. There was no evidence of leaks, damage, erosion, holes, plugged ports, cracks or potential malfunctions observed on any part of the diffuser.

Figure 1. Montecito outfall diffuser port pictures.
