Montecito Sanitary District's Response to the Thomas Fire 1/9 Debris Flow Event

July 17, 2018

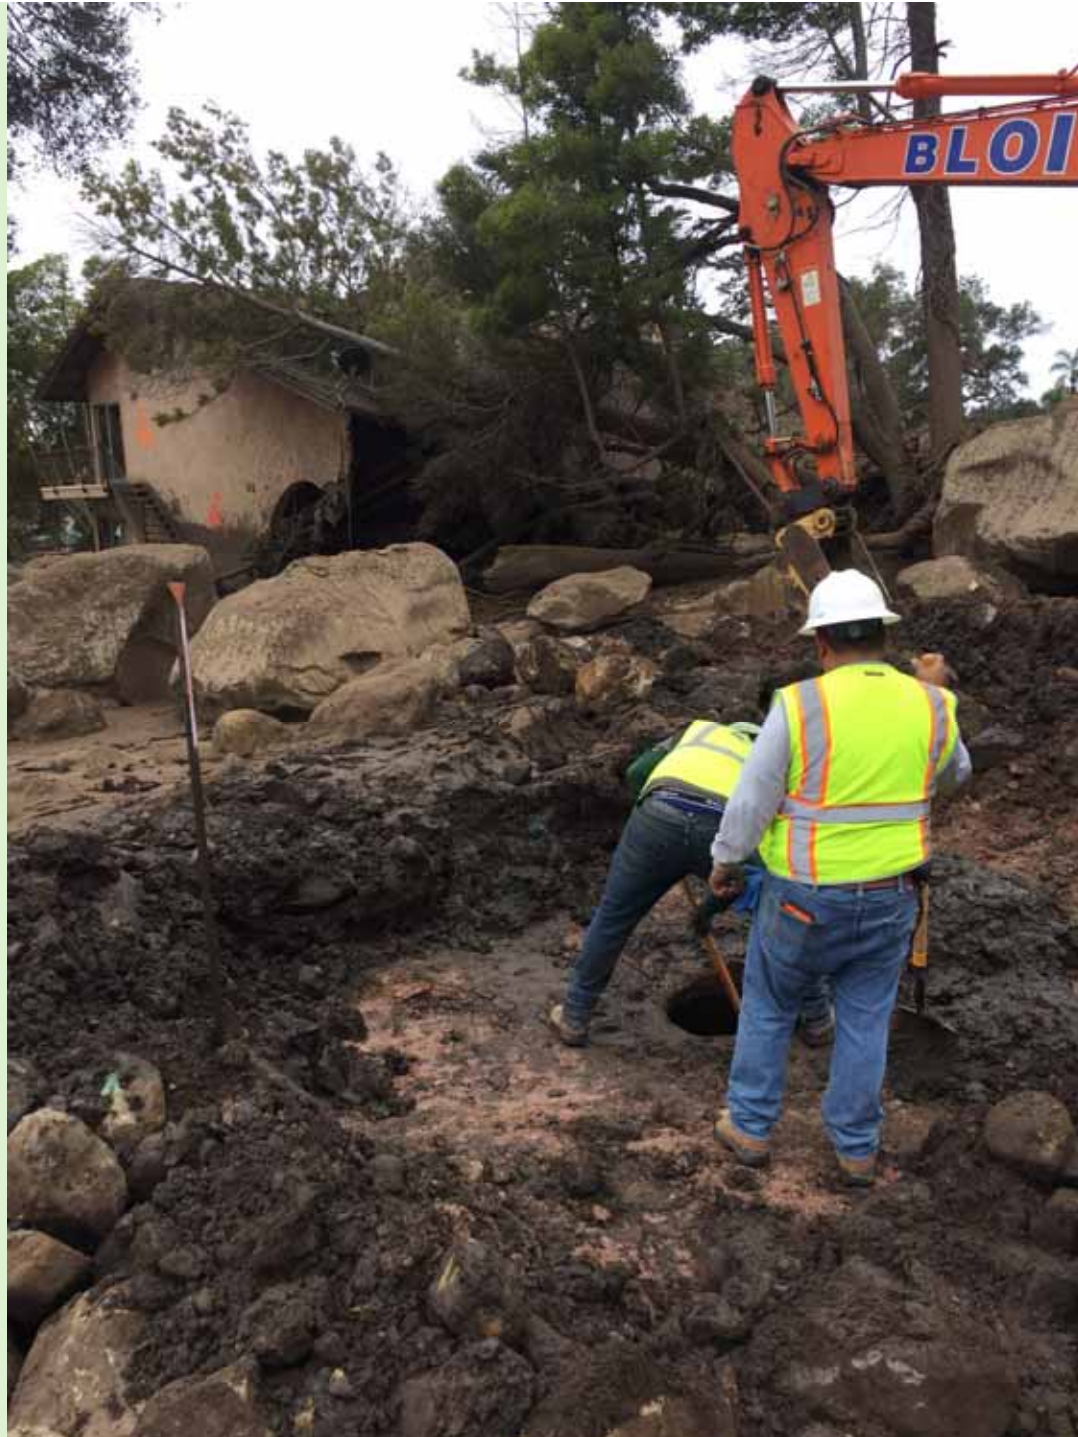
Once sewer manholes were located, Blois Construction (hired by MSD) cleared debris so manholes could be assessed for damage or debris in pipelines

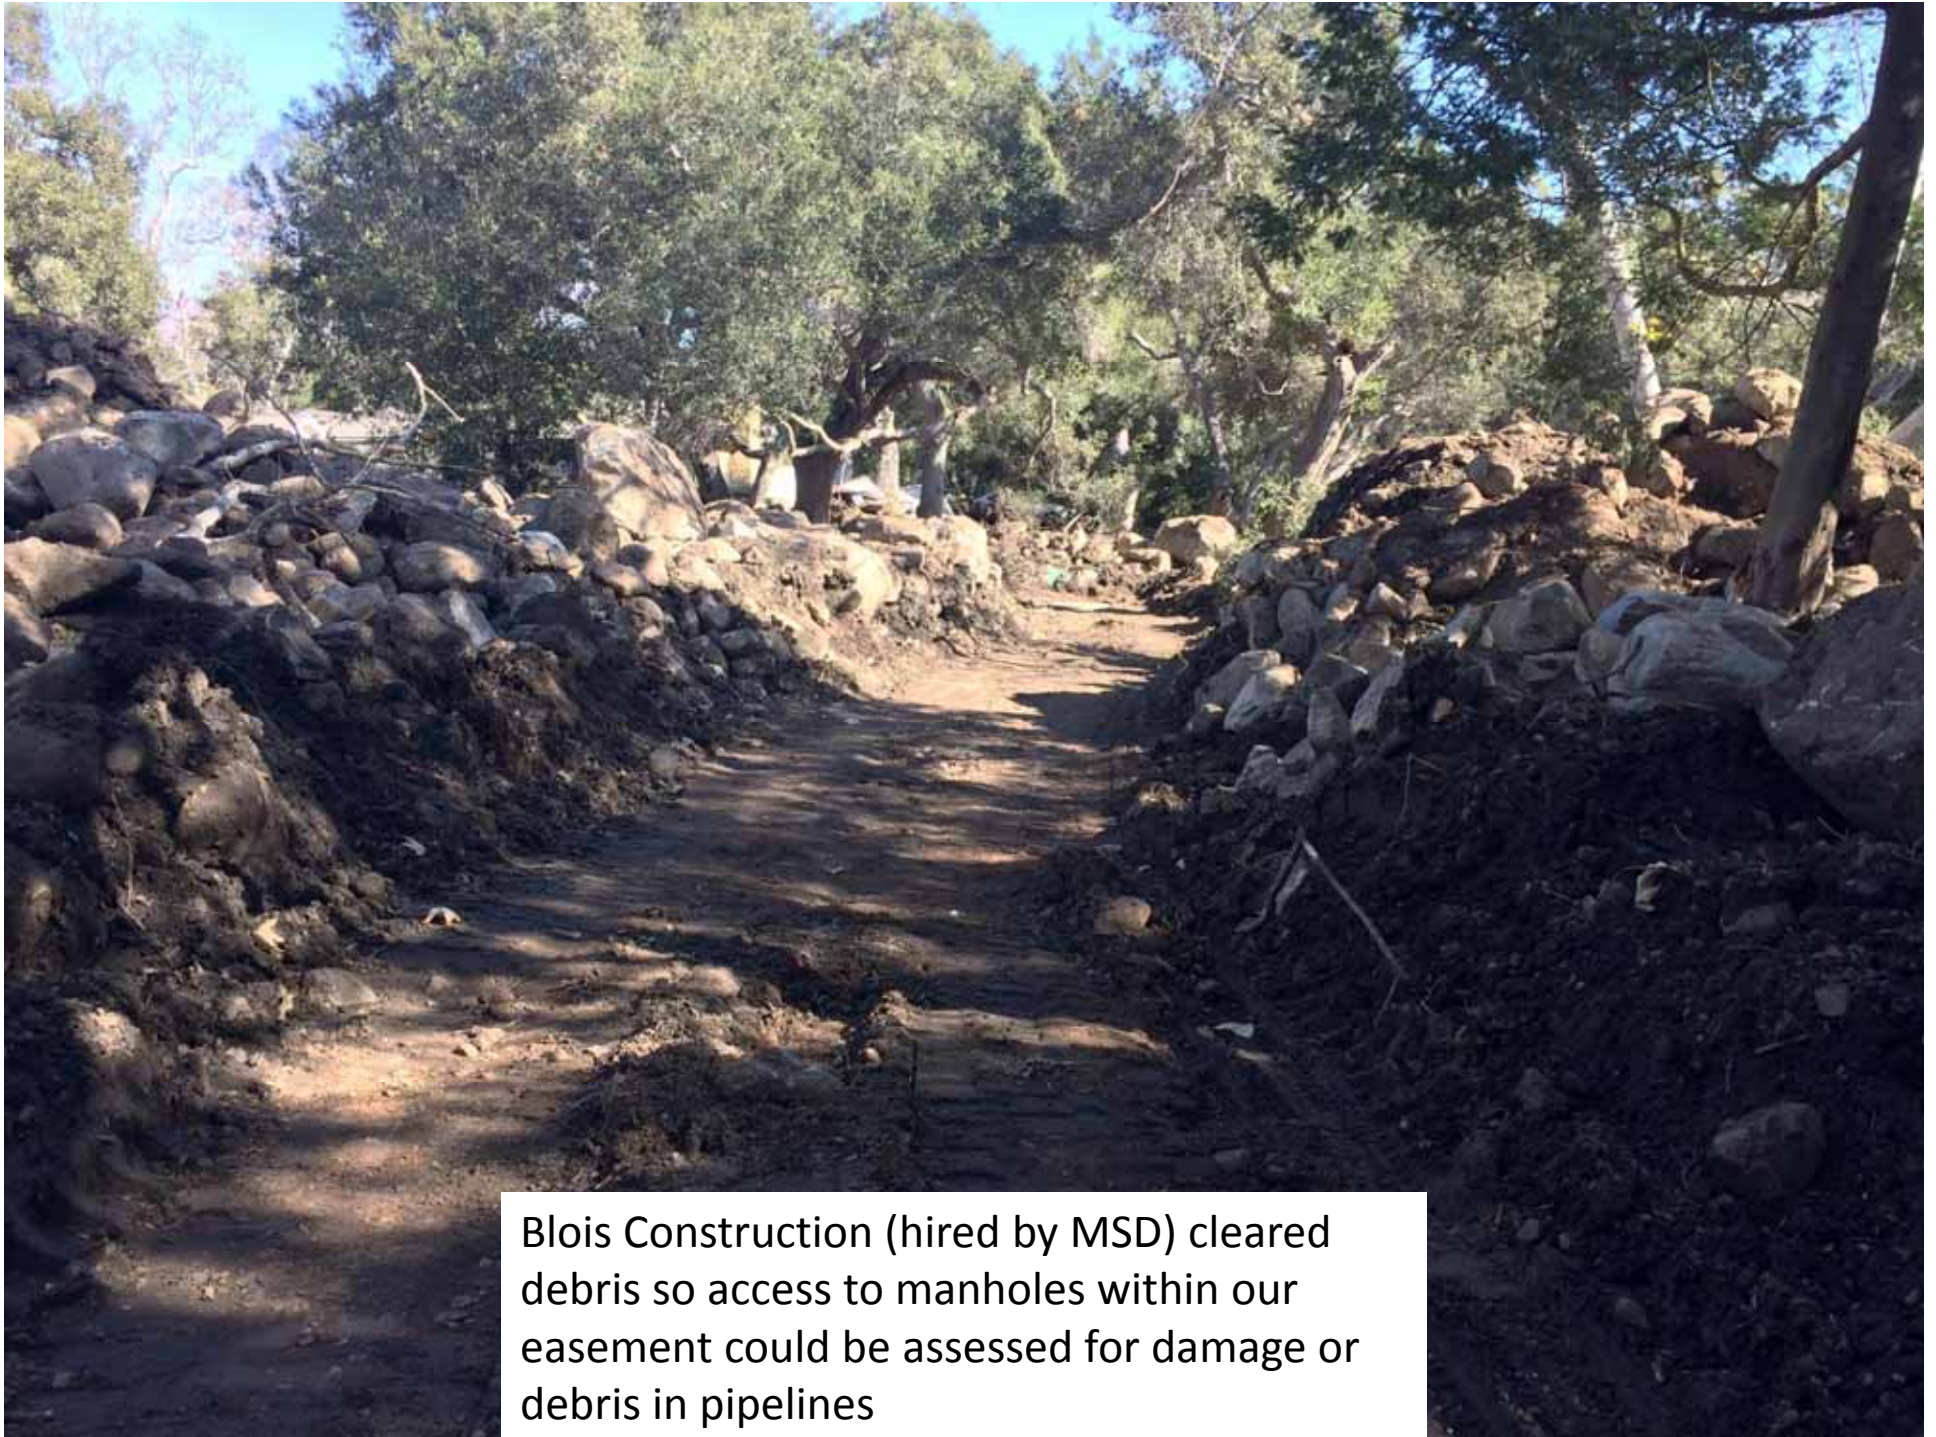
Blois Construction (hired by MSD) cleared debris so access to manholes within our easement could be assessed for damage or debris in pipelines

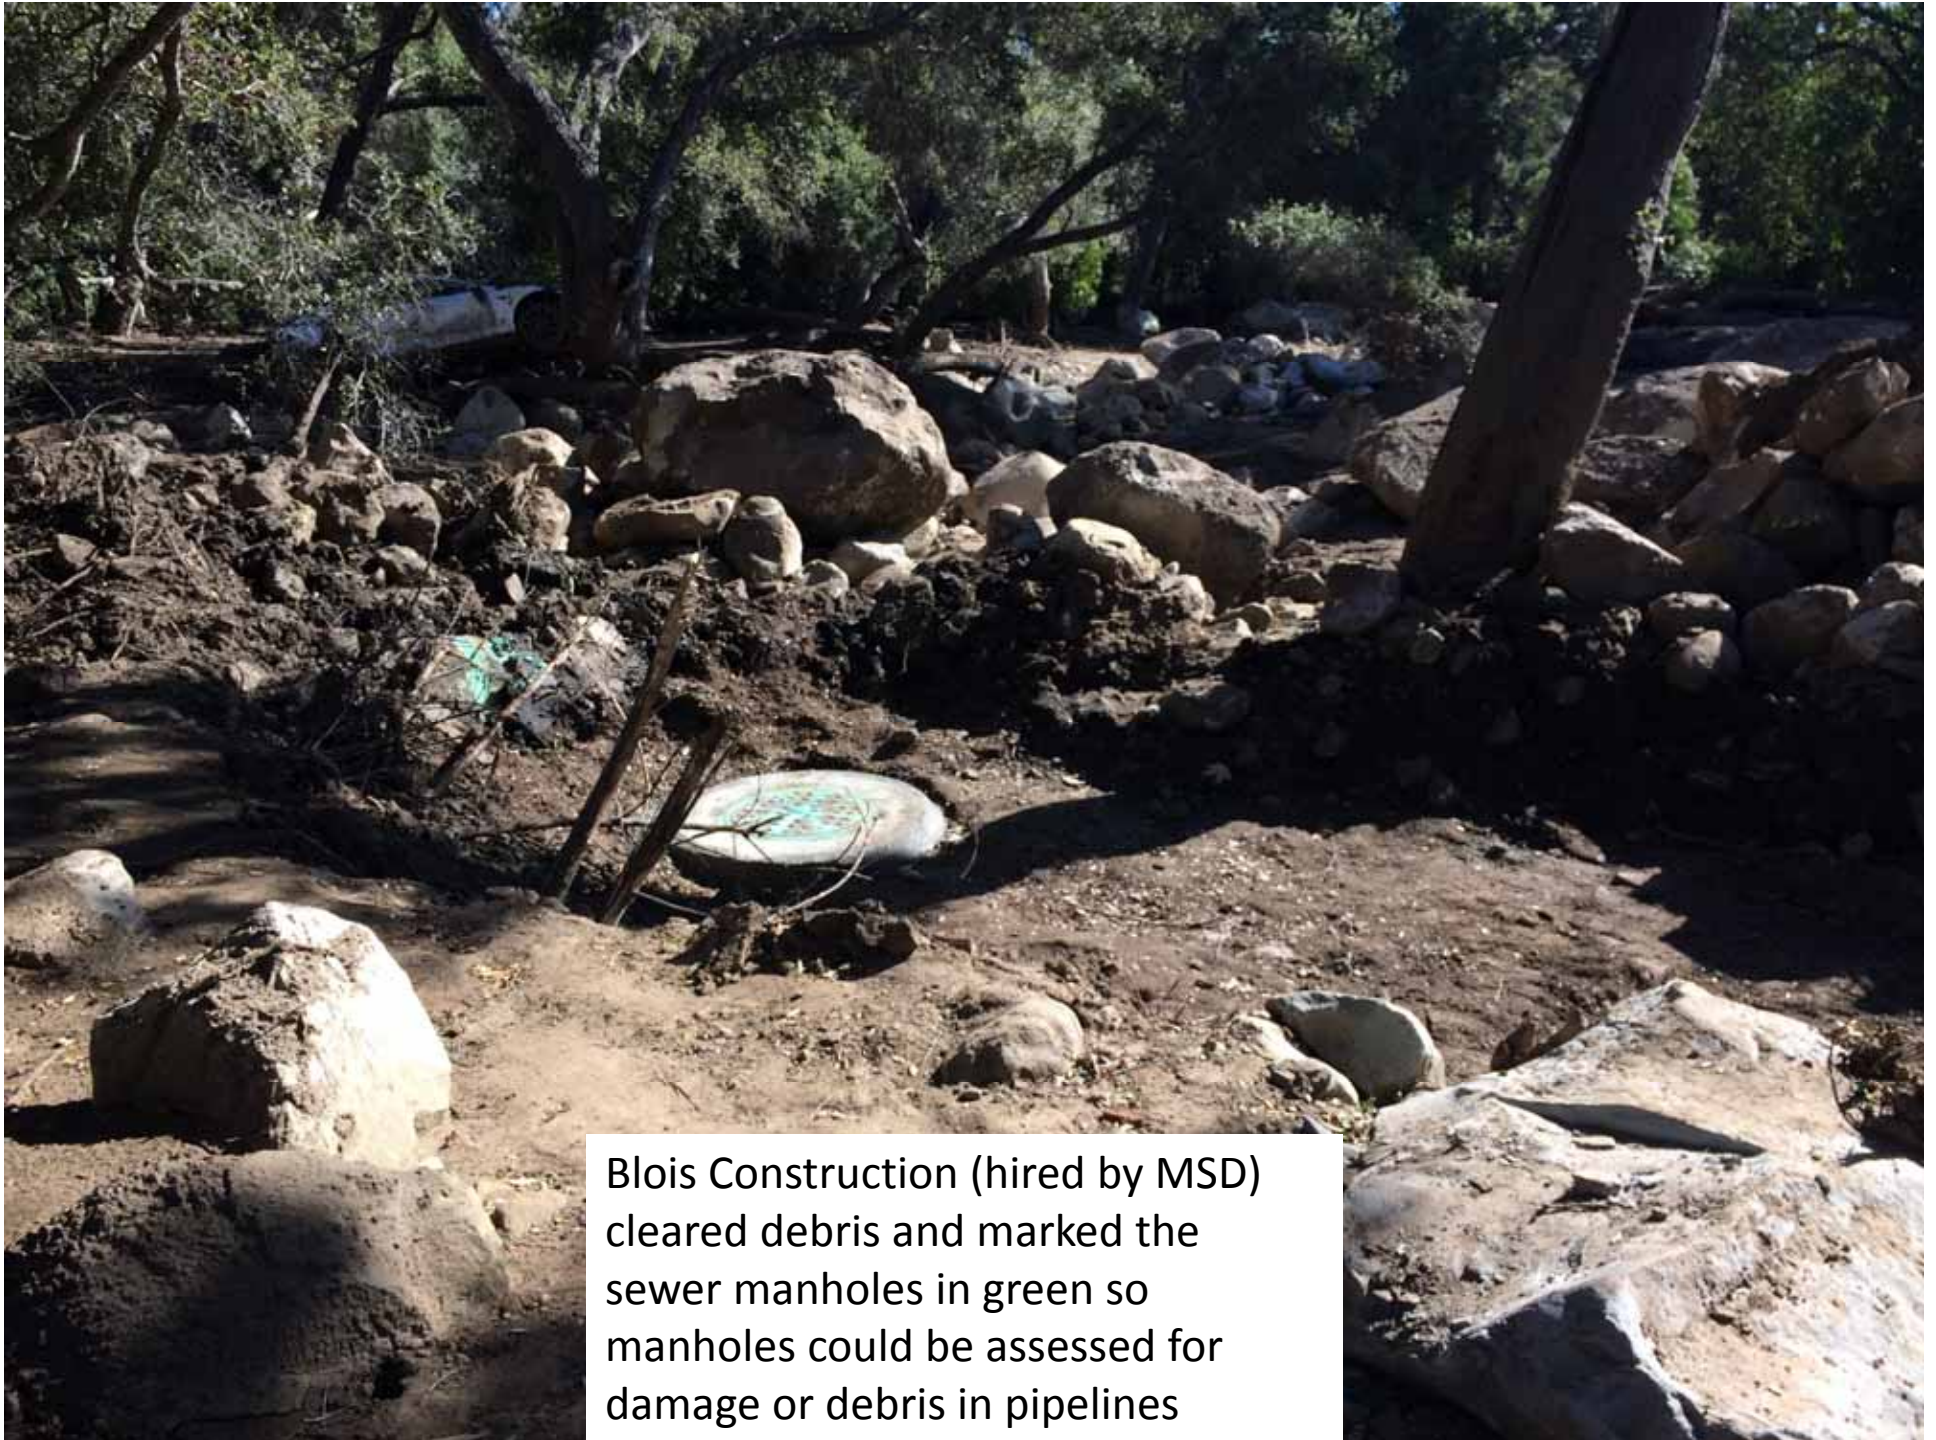
Blois Construction (hired by MSD) cleared debris and marked the sewer manholes in green so manholes could be assessed for damage or debris in pipelines

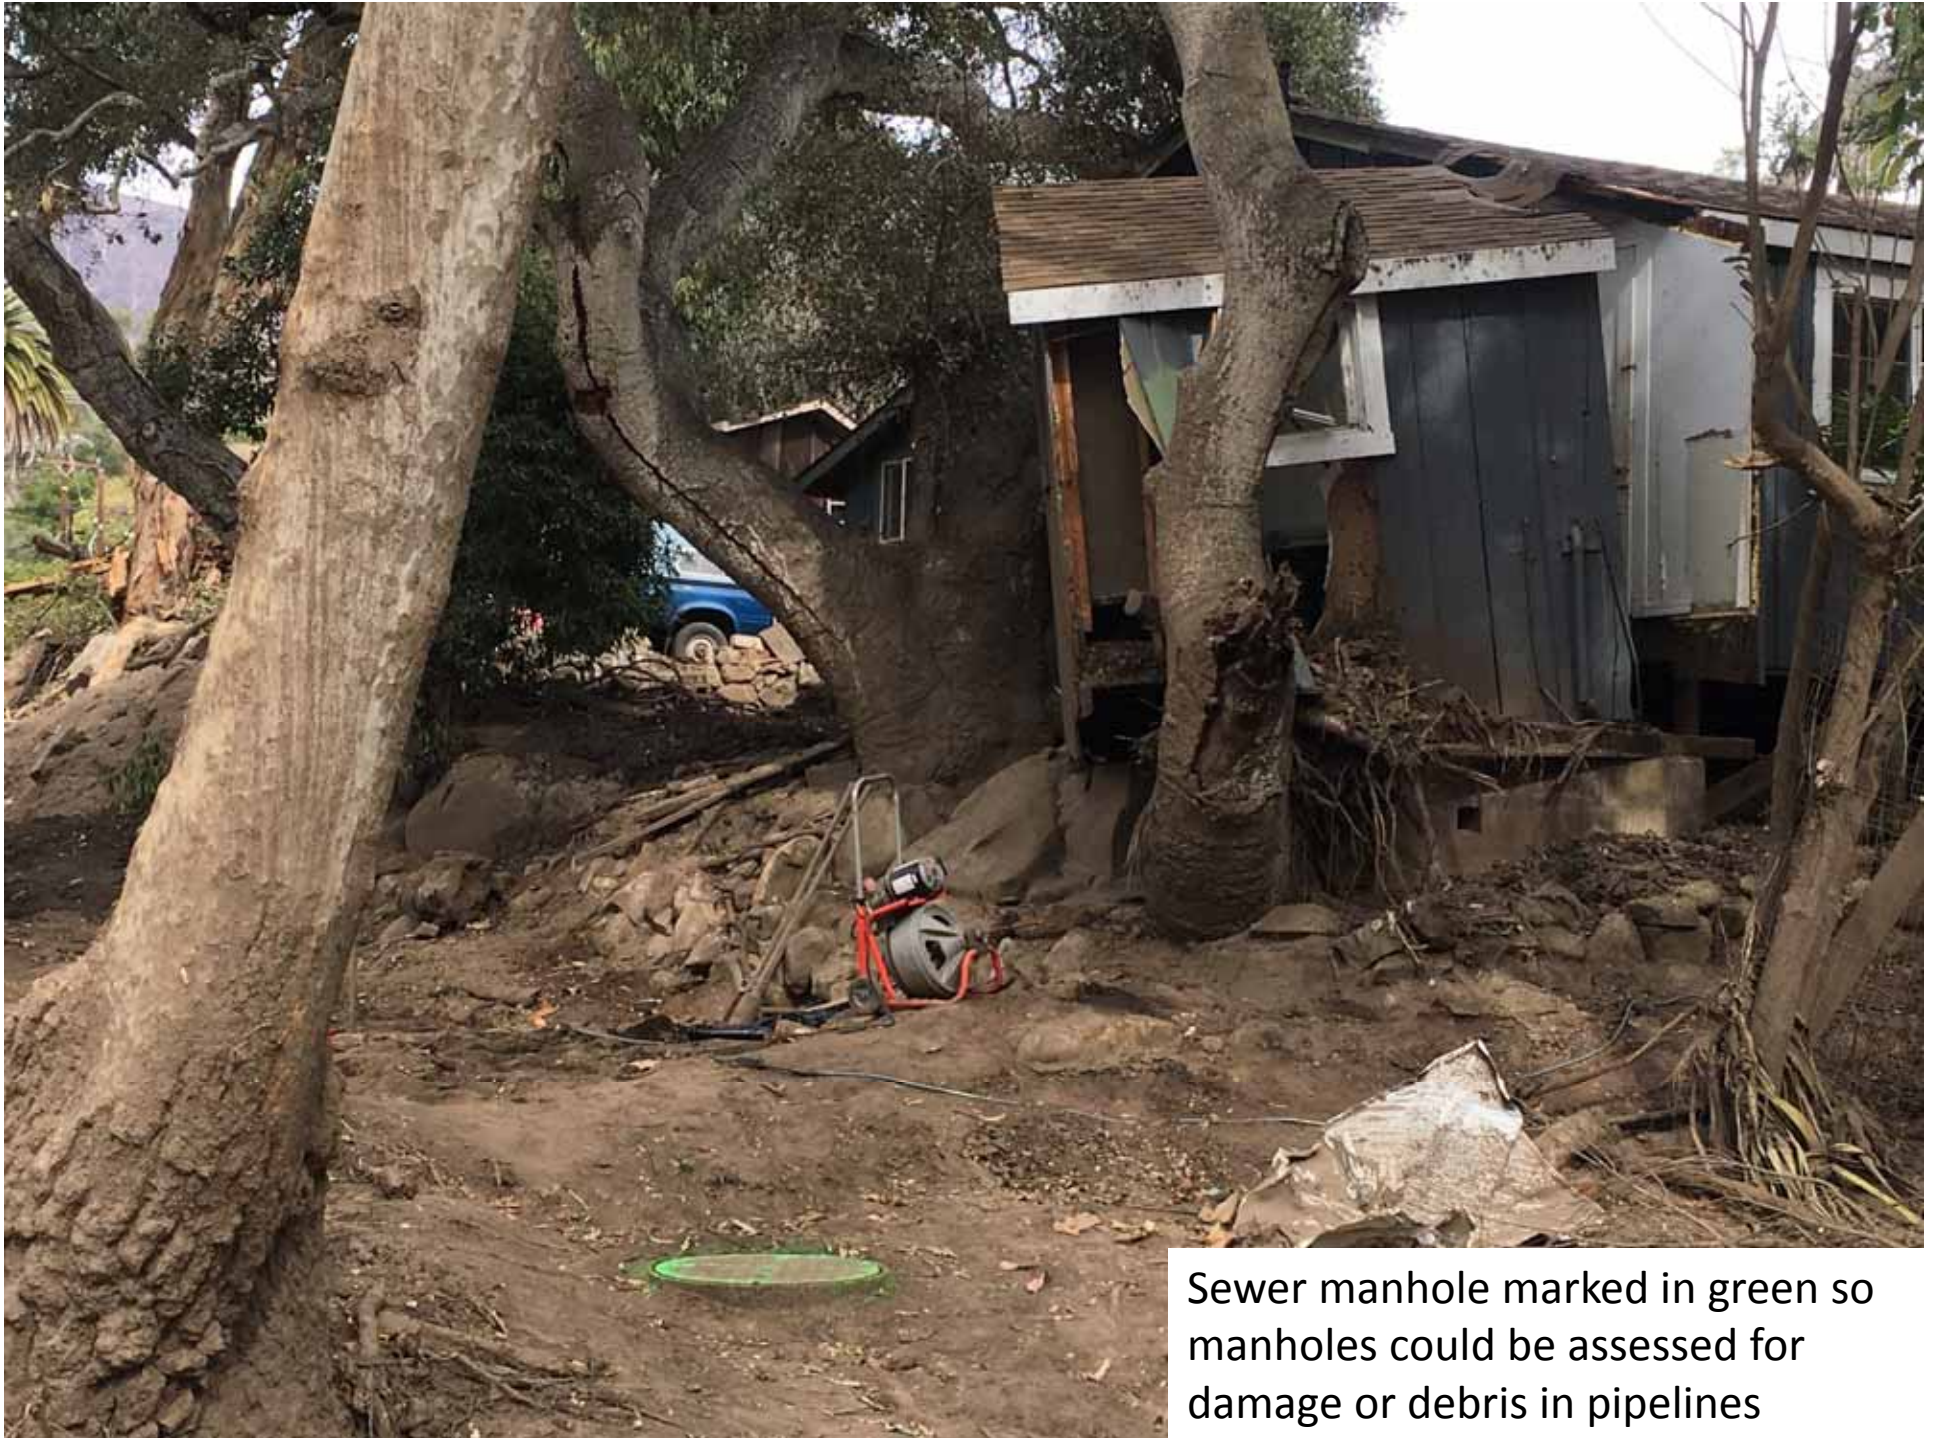
Sewer manhole marked in green so manholes could be assessed for damage or debris in pipelines

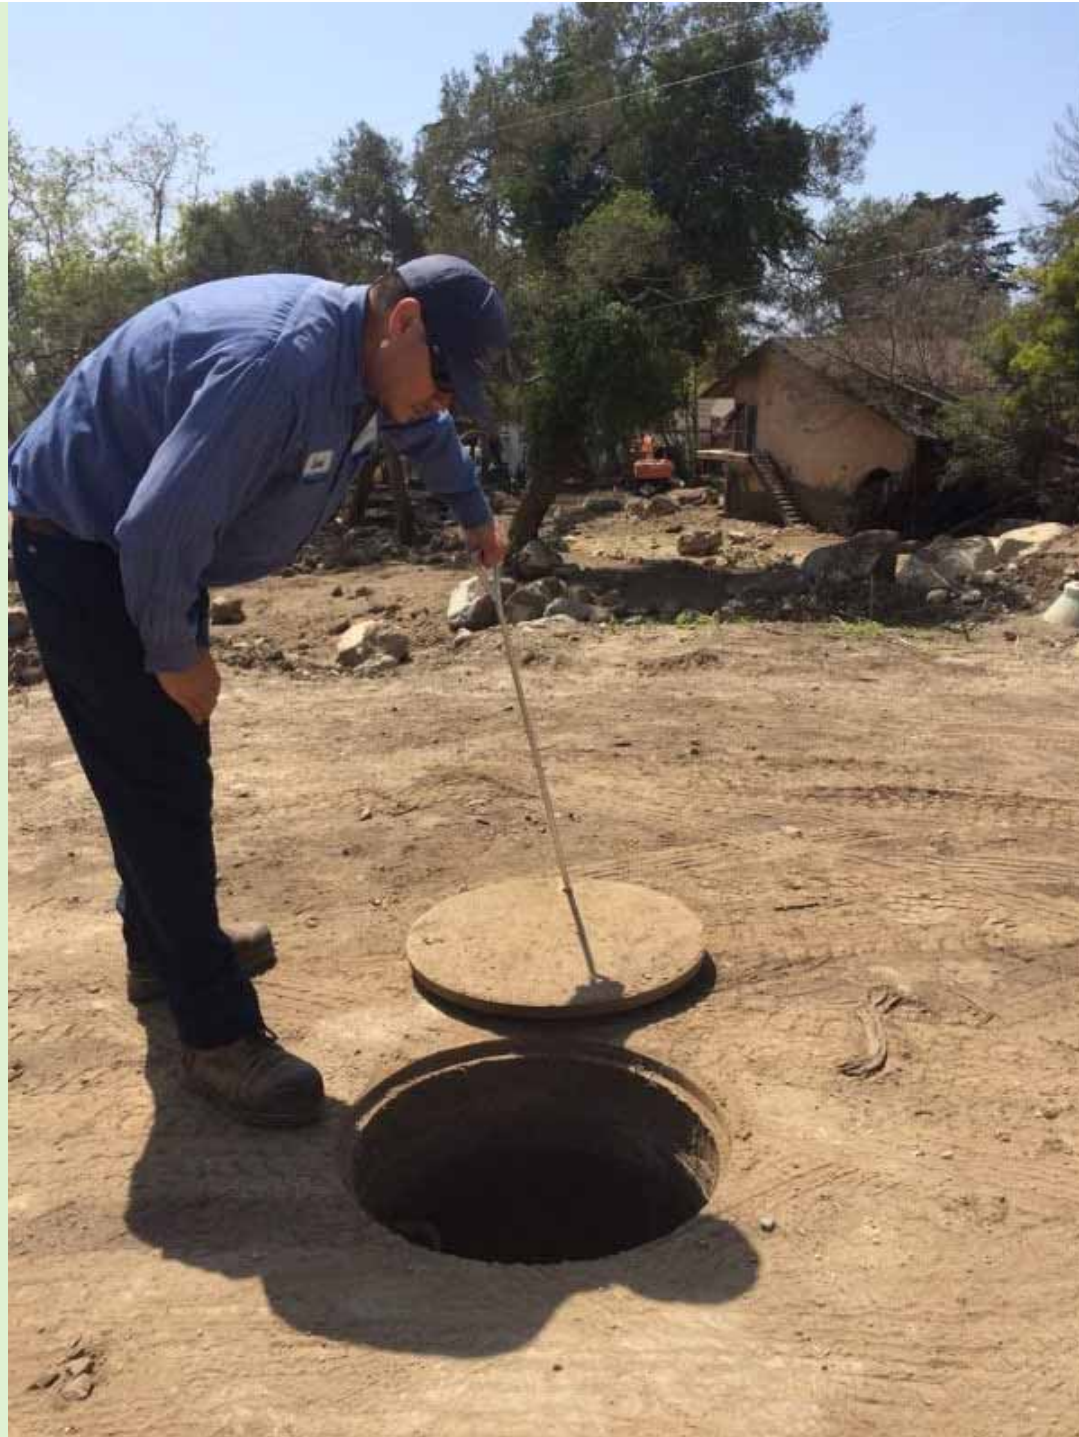
MSD Staff and Inspectors opened over 1,900 sewer manholes to see if manhole was damaged or if debris is in the pipeline below

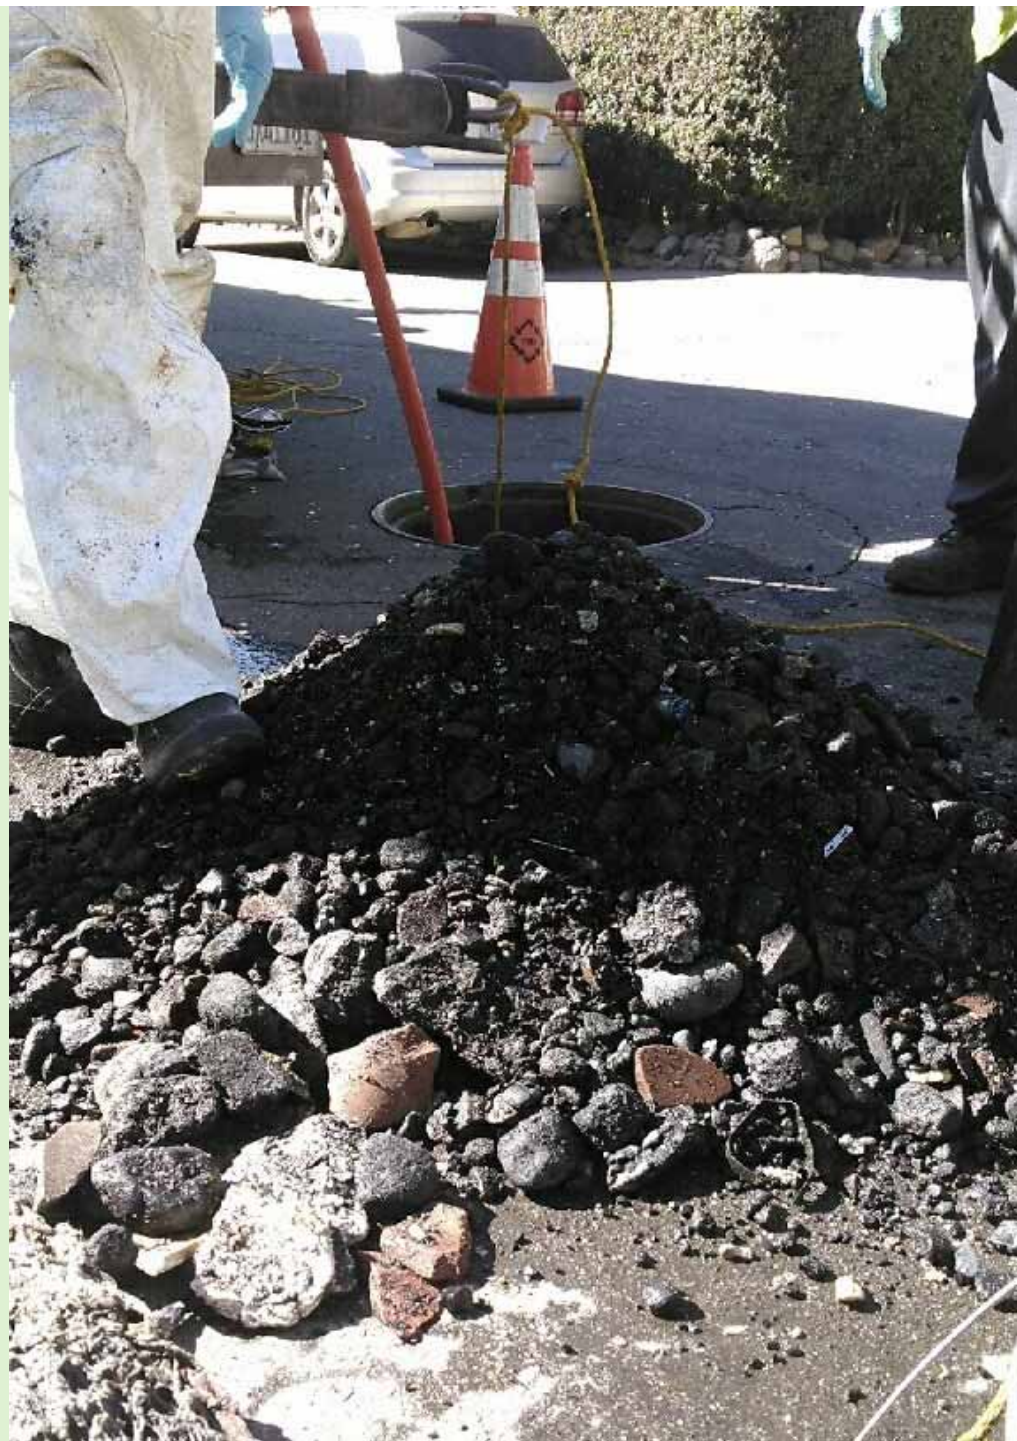
MSD hired National Plant Services to clean the debris from the sewer manholes and pipelines- this is an example of the debris that was removed

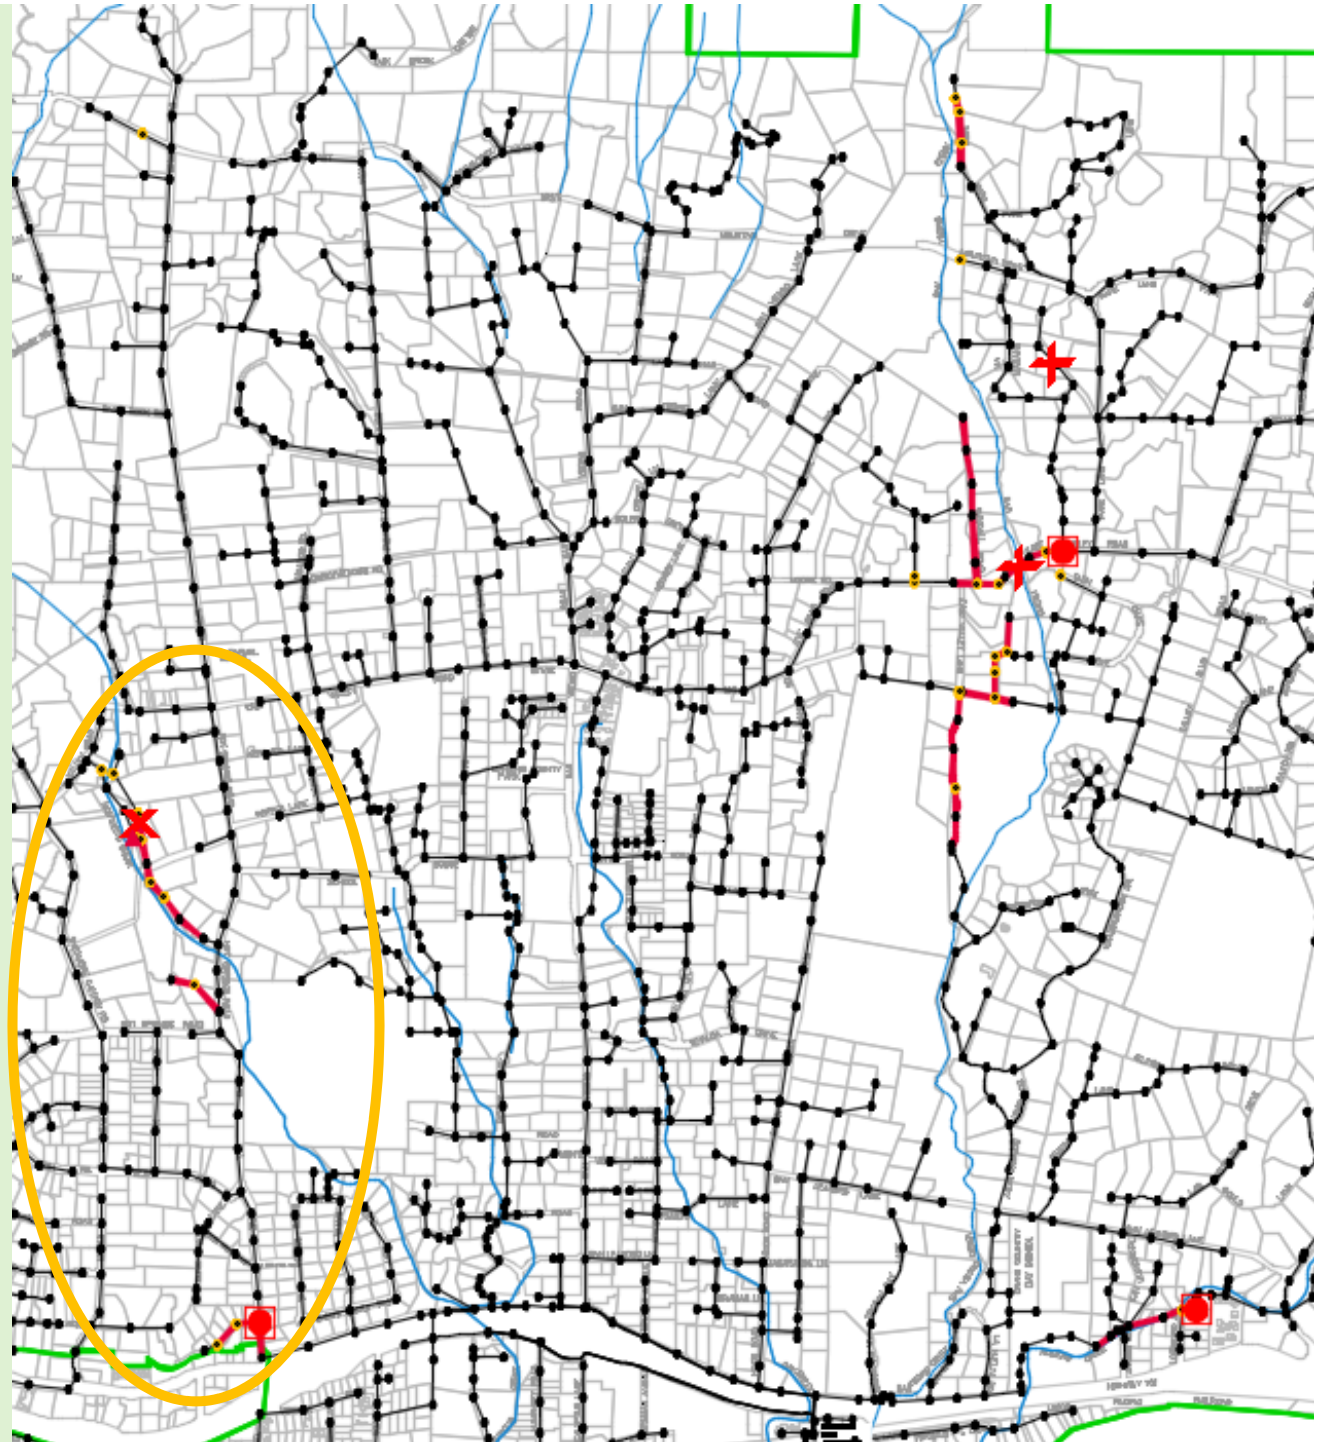
COLLECTION SYSTEM DAMAGE- MONTECITO CREEK

Sewer Pipeline Break
-

Sewer Pipeline full of Debris
-

Sanitary Sewer Overflow (due to storm water intrusion and debris blocked pipes)

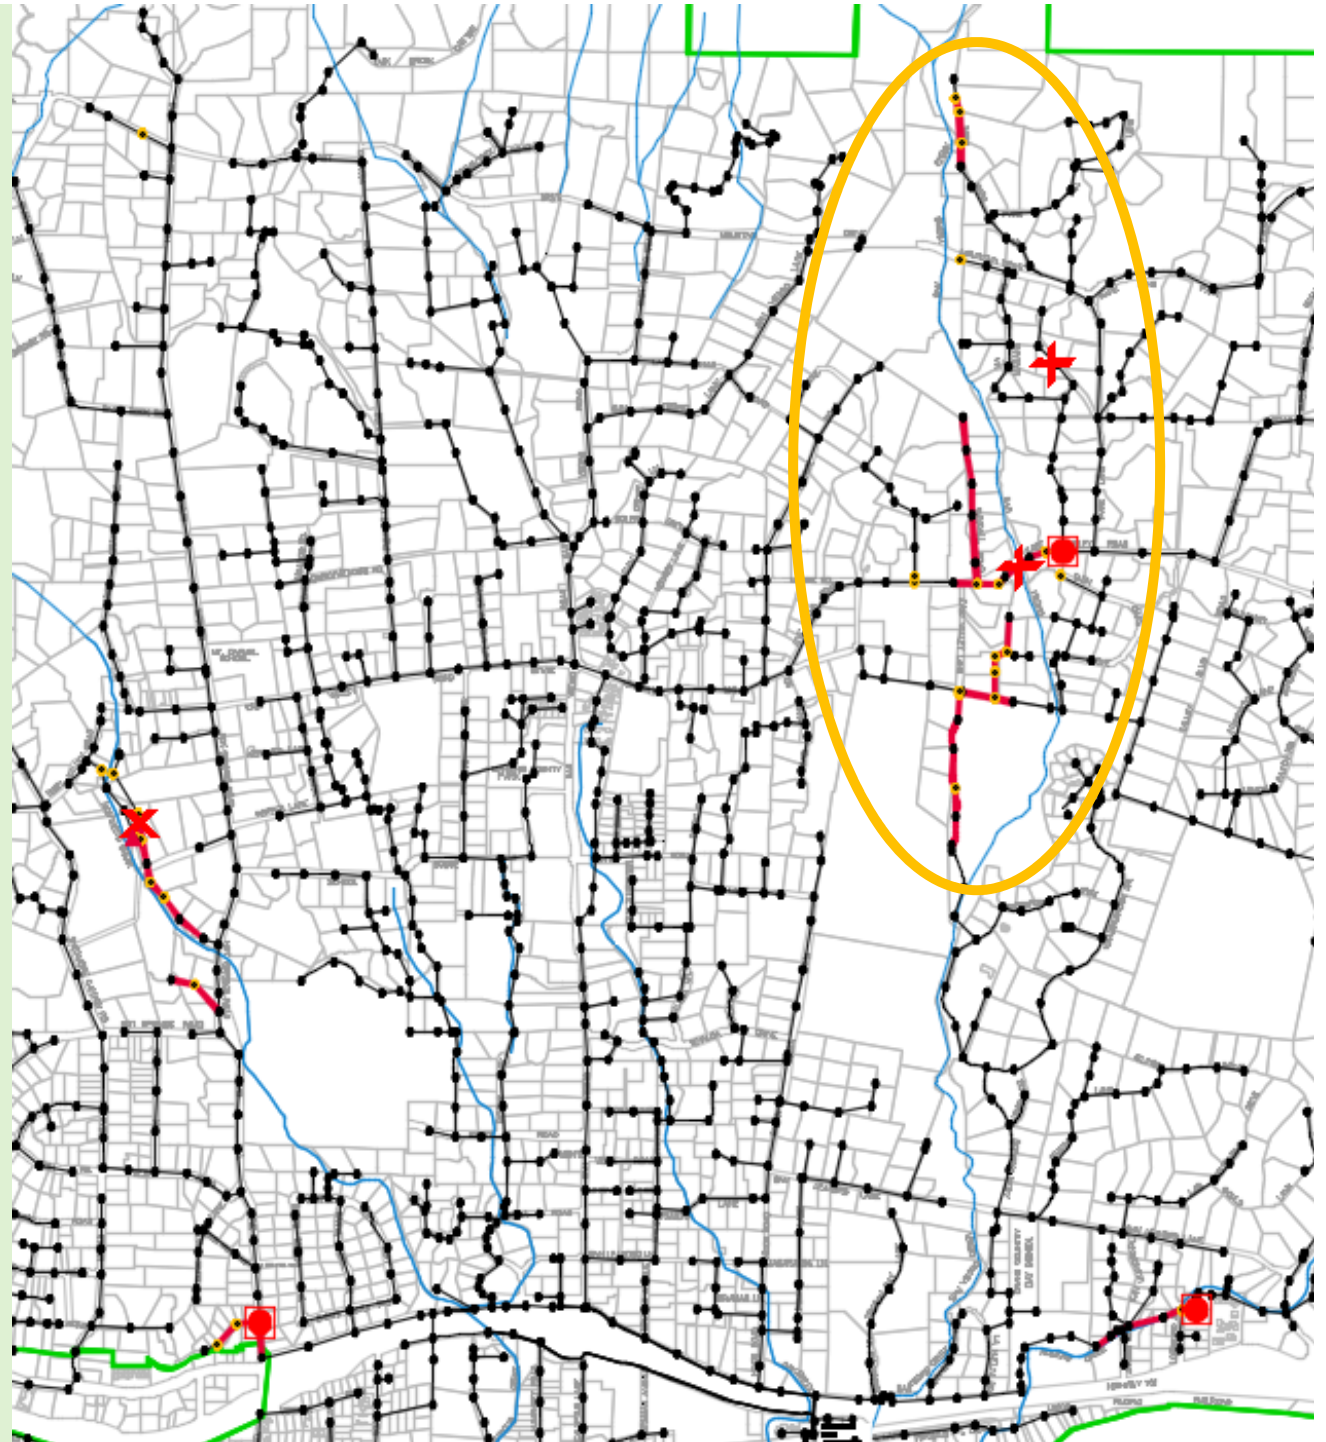
COLLECTION SYSTEM DAMAGE- SAN YSIDRO CREEK

Sewer Pipeline Break

Sewer Pipeline full of Debris

Sanitary Sewer Overflow (due to storm water intrusion and debris blocked pipes)

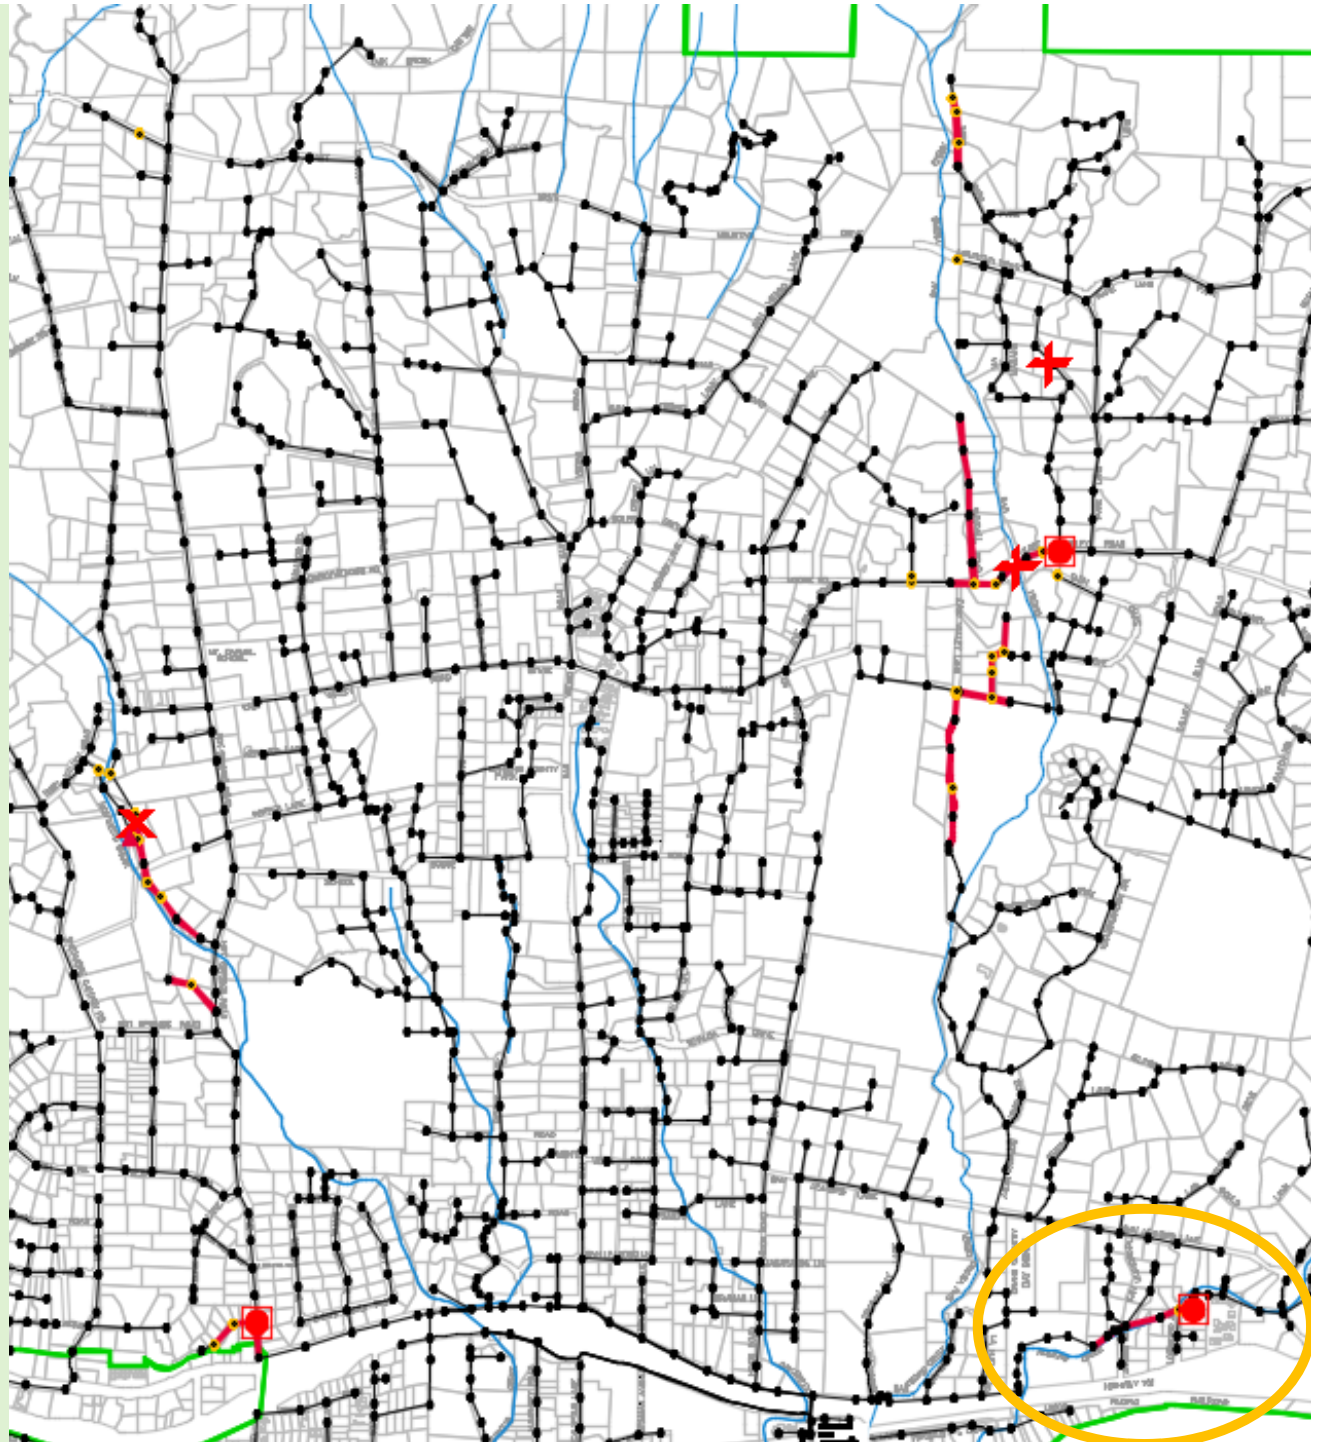
COLLECTION SYSTEM DAMAGE- ROMERO CREEK

Sewer Pipeline Break
-

Sewer Pipeline full of Debris
-

Sanitary Sewer Overflow (due to storm water intrusion and debris blocked pipes)

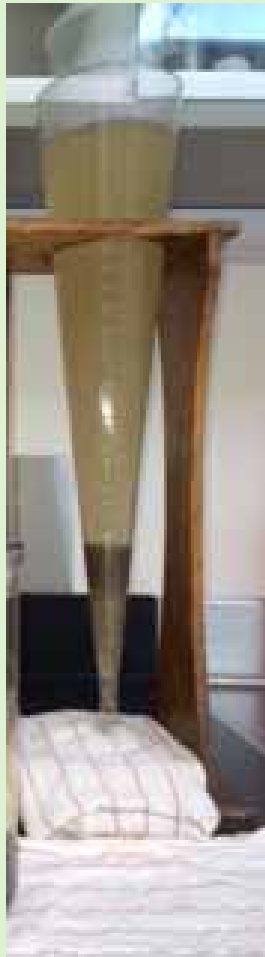
Typical Day

Typical day influent is tan in color, has a trace amount of solids material, and has a musty odor

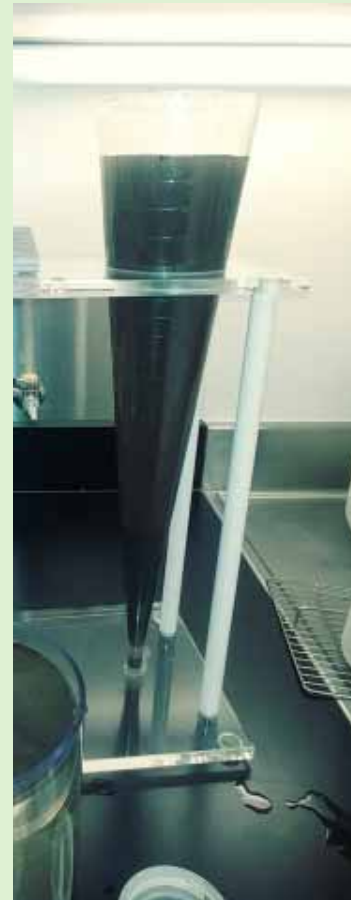
January 9, 2018

On the morning of the debris flow influent was a blackish-brown slurry and had an earthy odor; the debris in the collection system was making its way to the treatment plant. This is what the influent flow looked like for weeks.

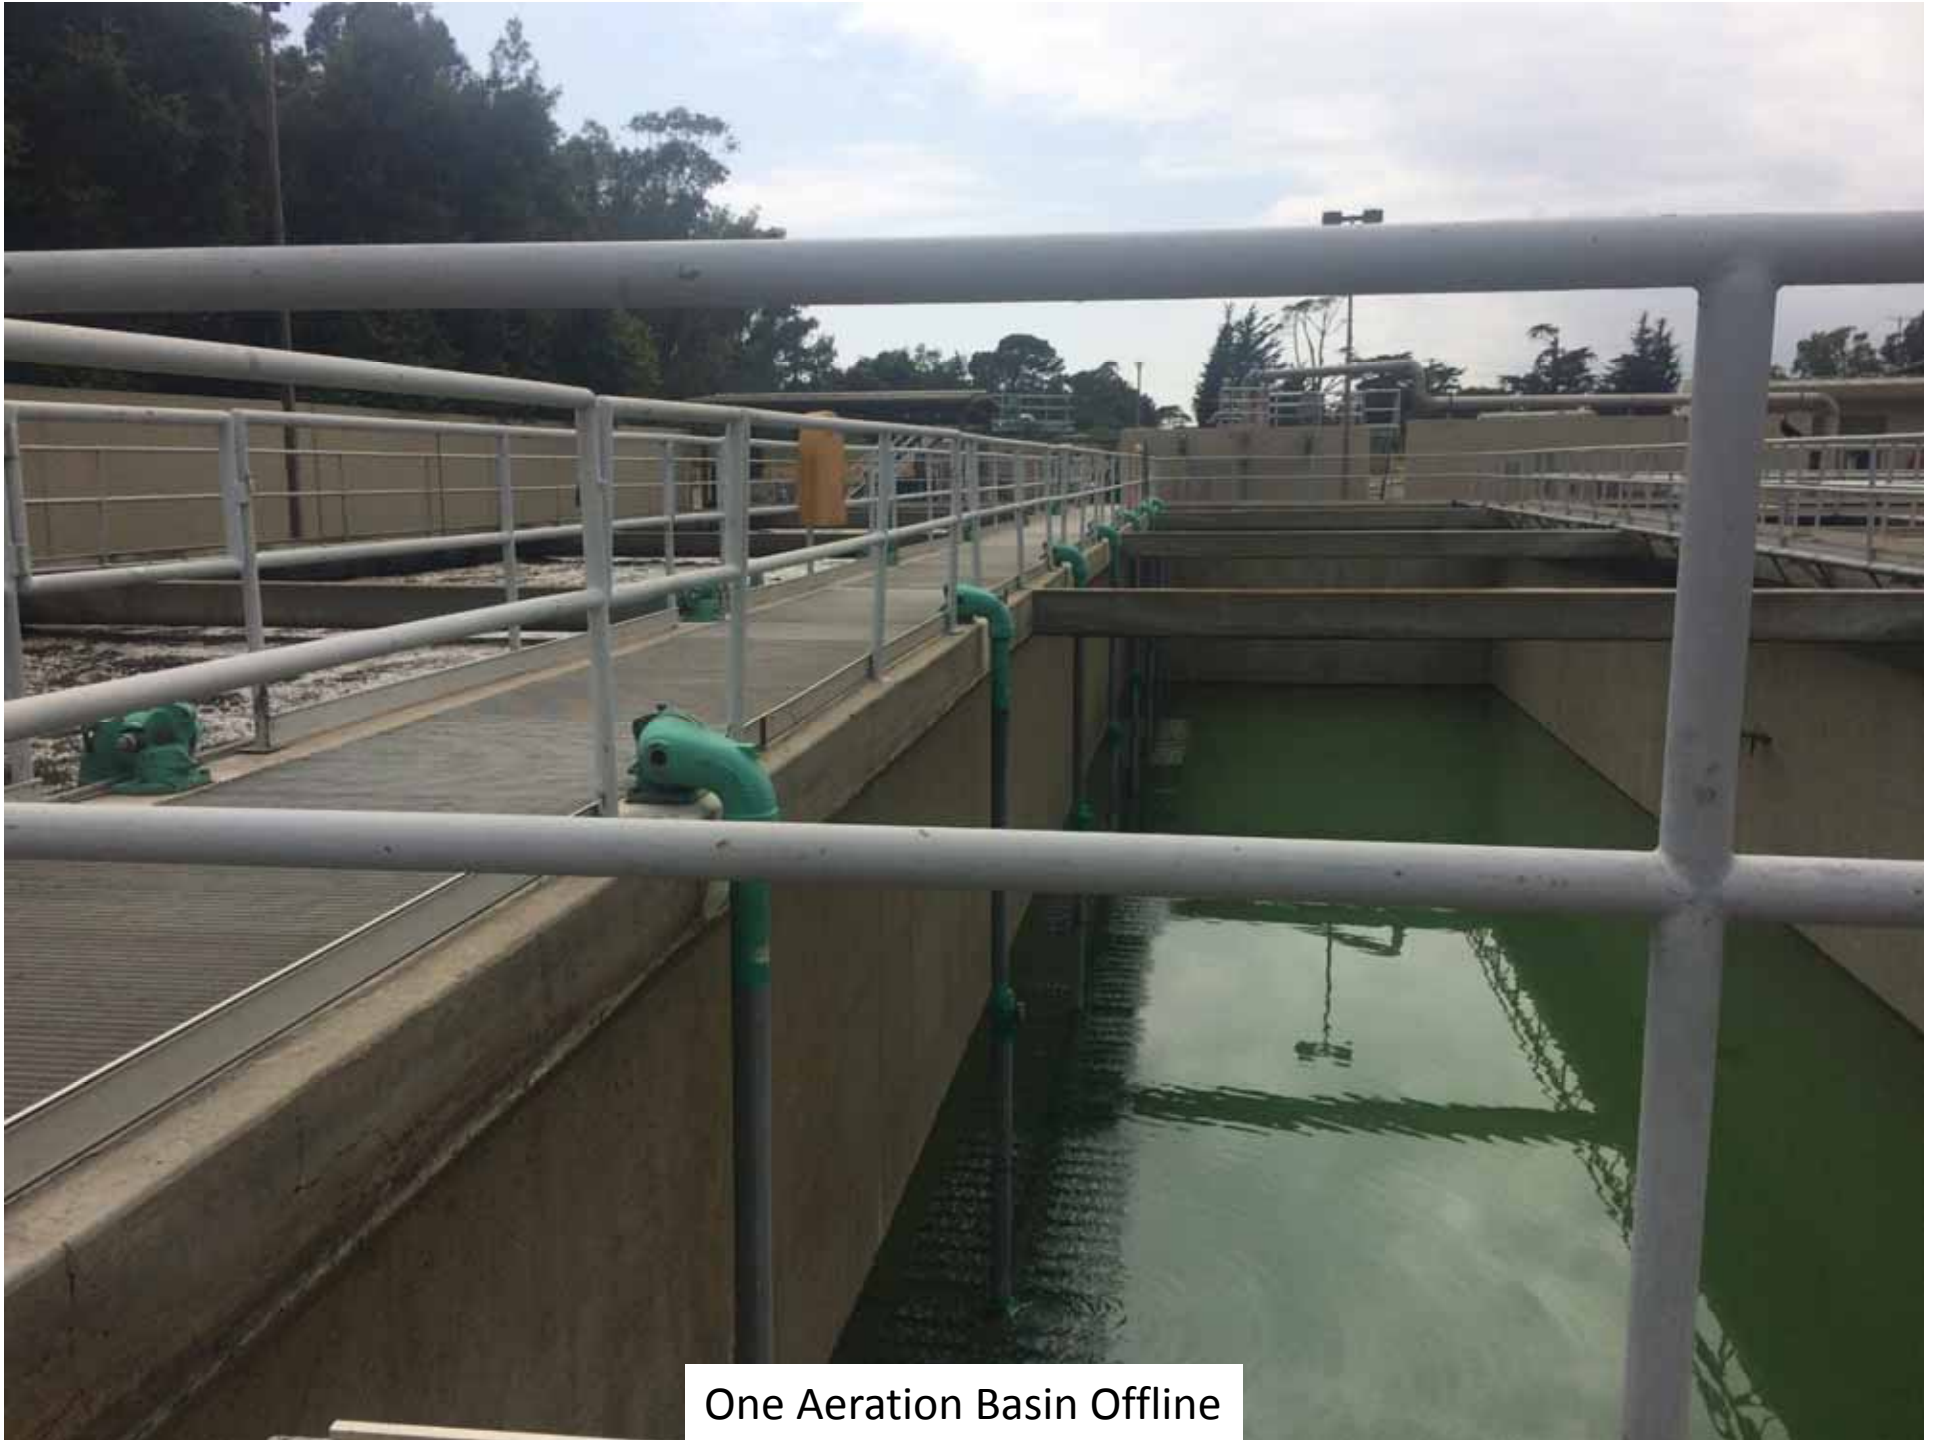
One Aeration Basin Offline

With very low flows to the treatment plant both the hydraulic and the solids residence times in these tanks were far beyond our target ranges. As the flow into the plant dropped below half of normal, we took half of our tanks offline.
