Montecito Sanitary District's Response to the Thomas Fire 1/9 Debris Flow Event

July 17, 2018

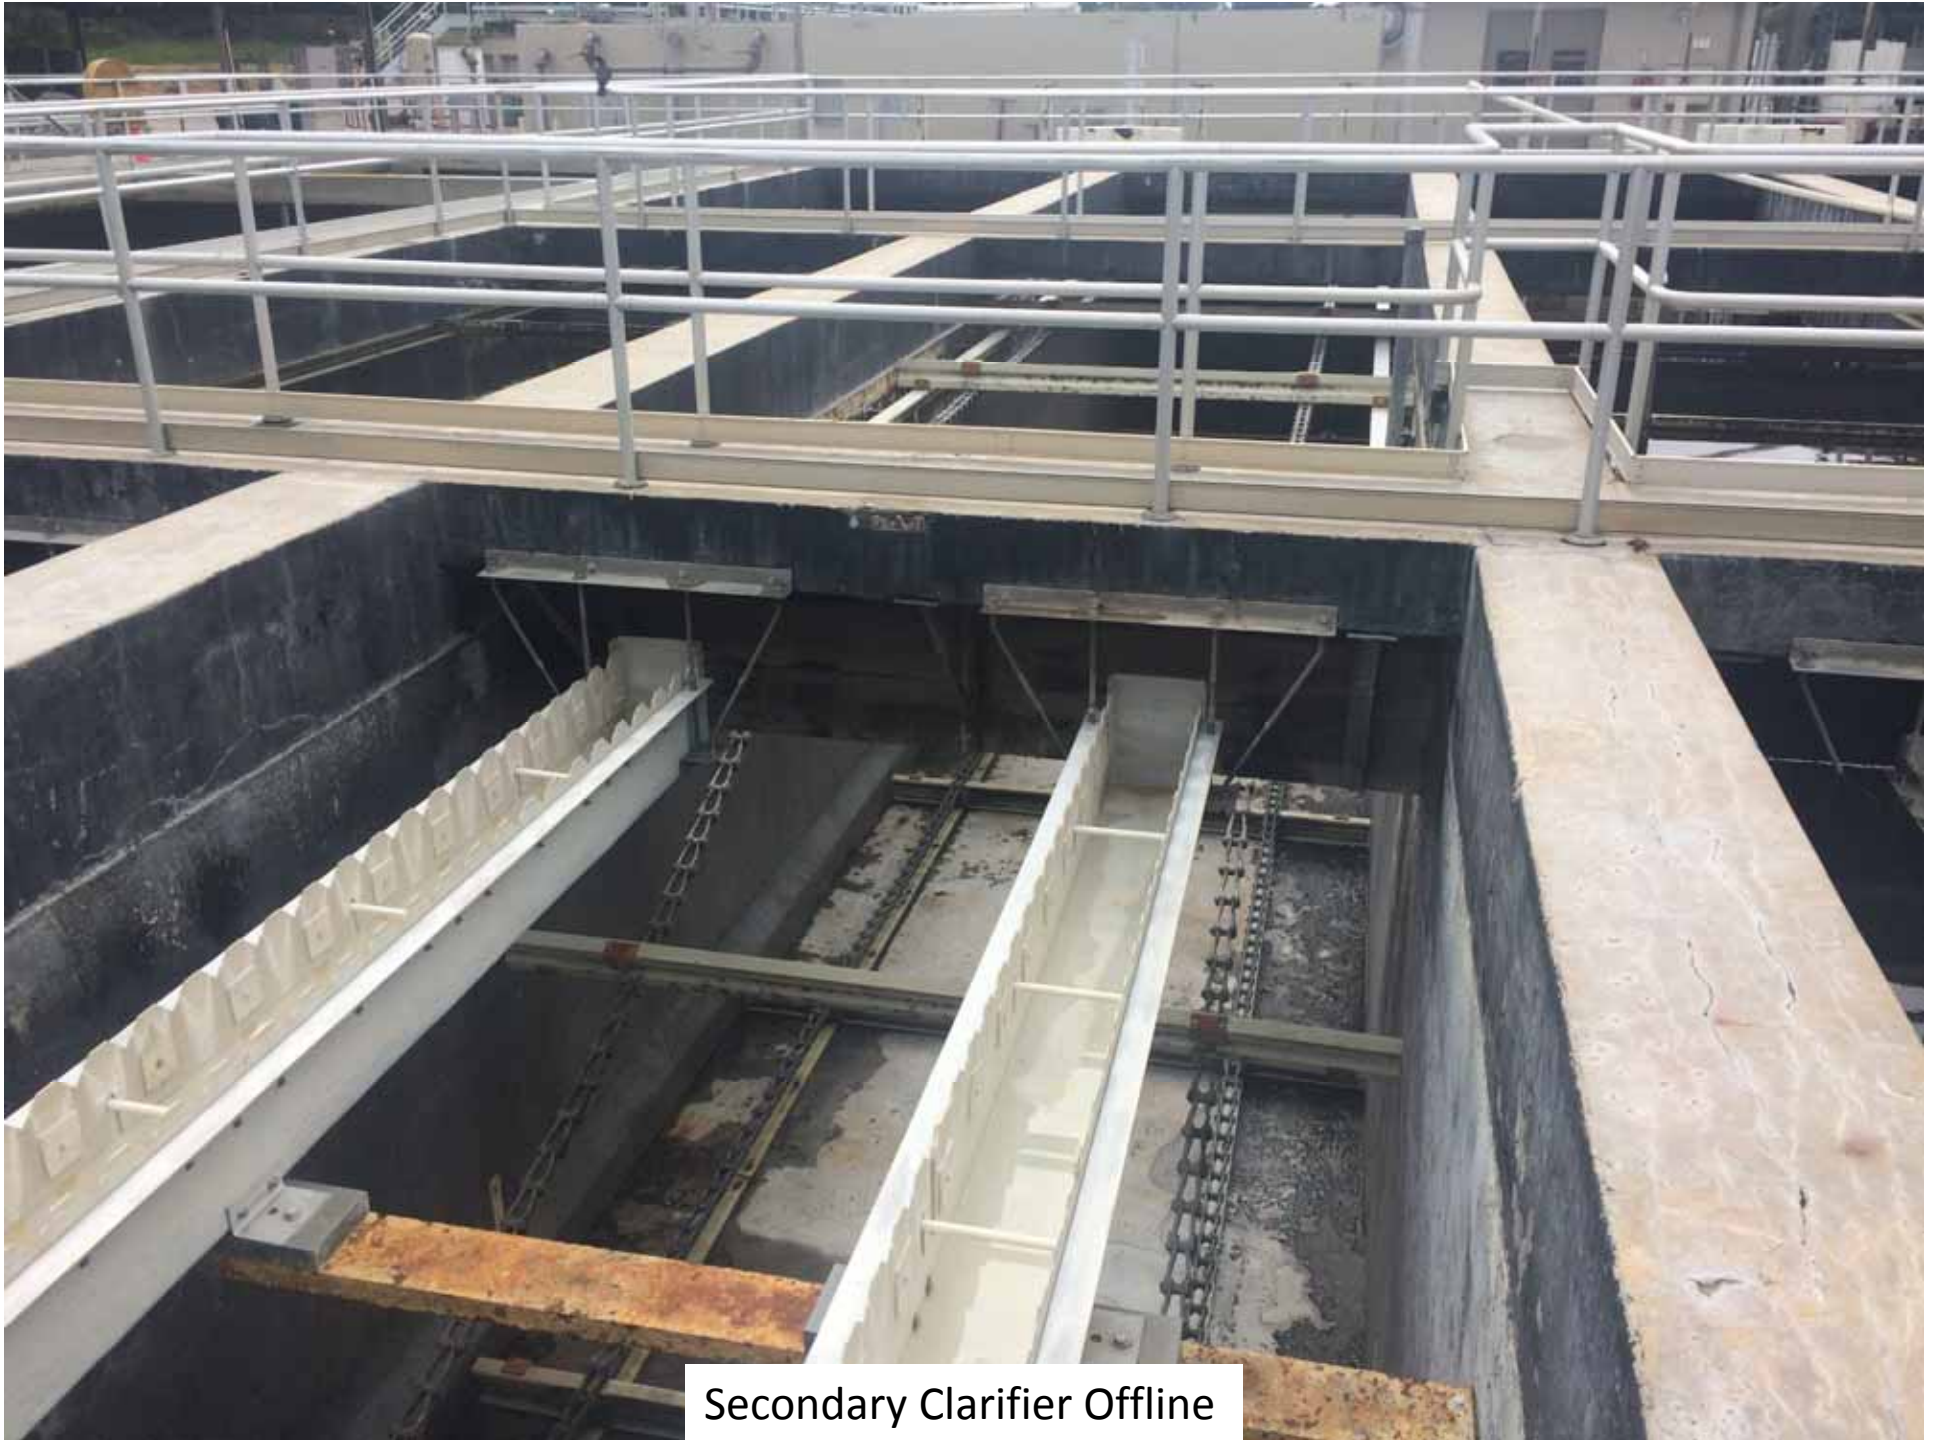
Secondary Clarifier Offline

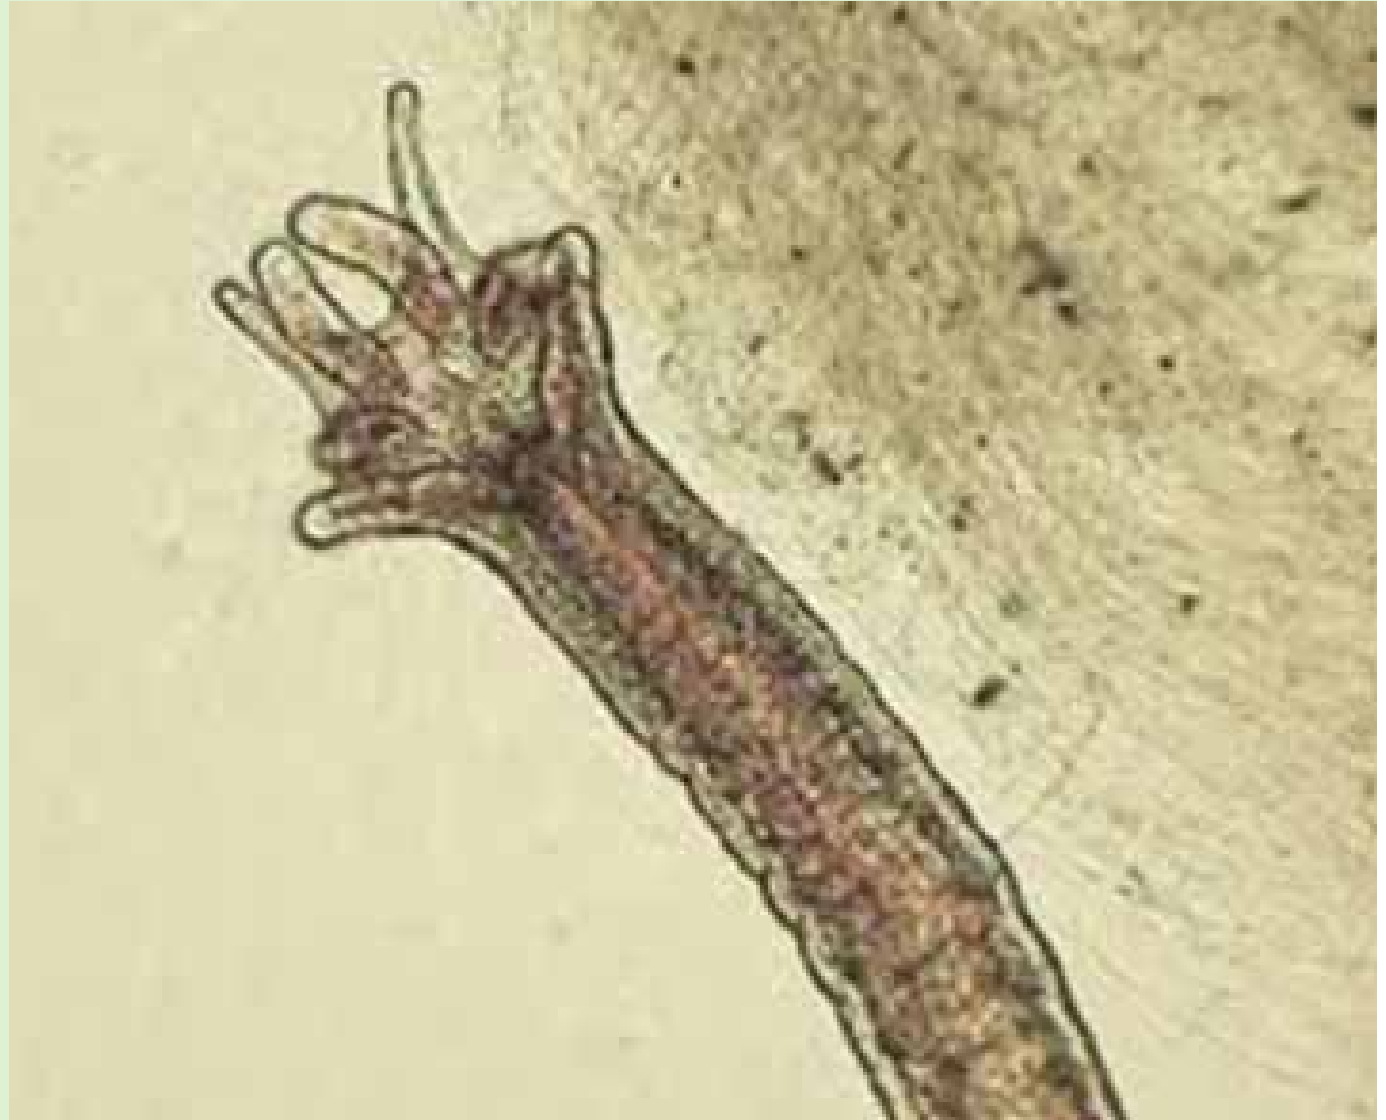
Preventing Worms

These worms are associated with sub-optimal treatment performance. After the debris flow, we were striving to prevent these worms by maintaining the healthy, beneficial microorganisms that ultimately keep us in permit compliance. Human sanitary sewer waste is the food that good microorganisms need to eat in order to live. After the debris flow, our microorganisms were basically starving.

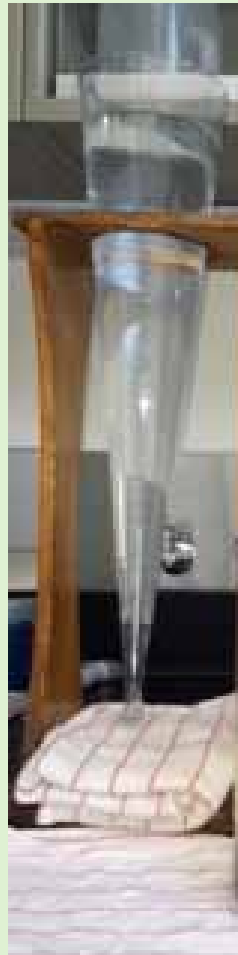
Typical Day

Effluent is crystal clear

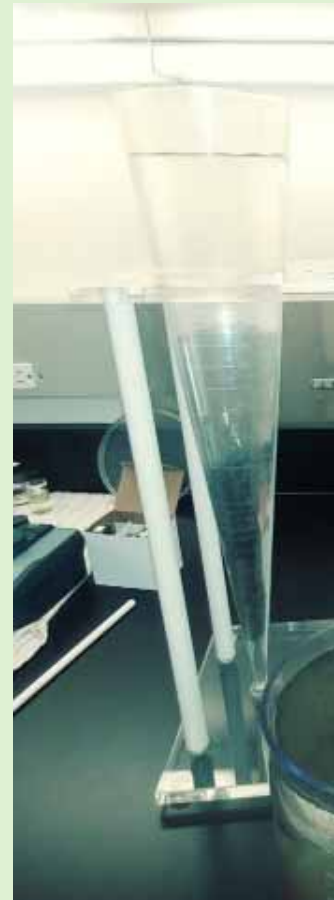
January 9, 2018

Effluent is quite clear

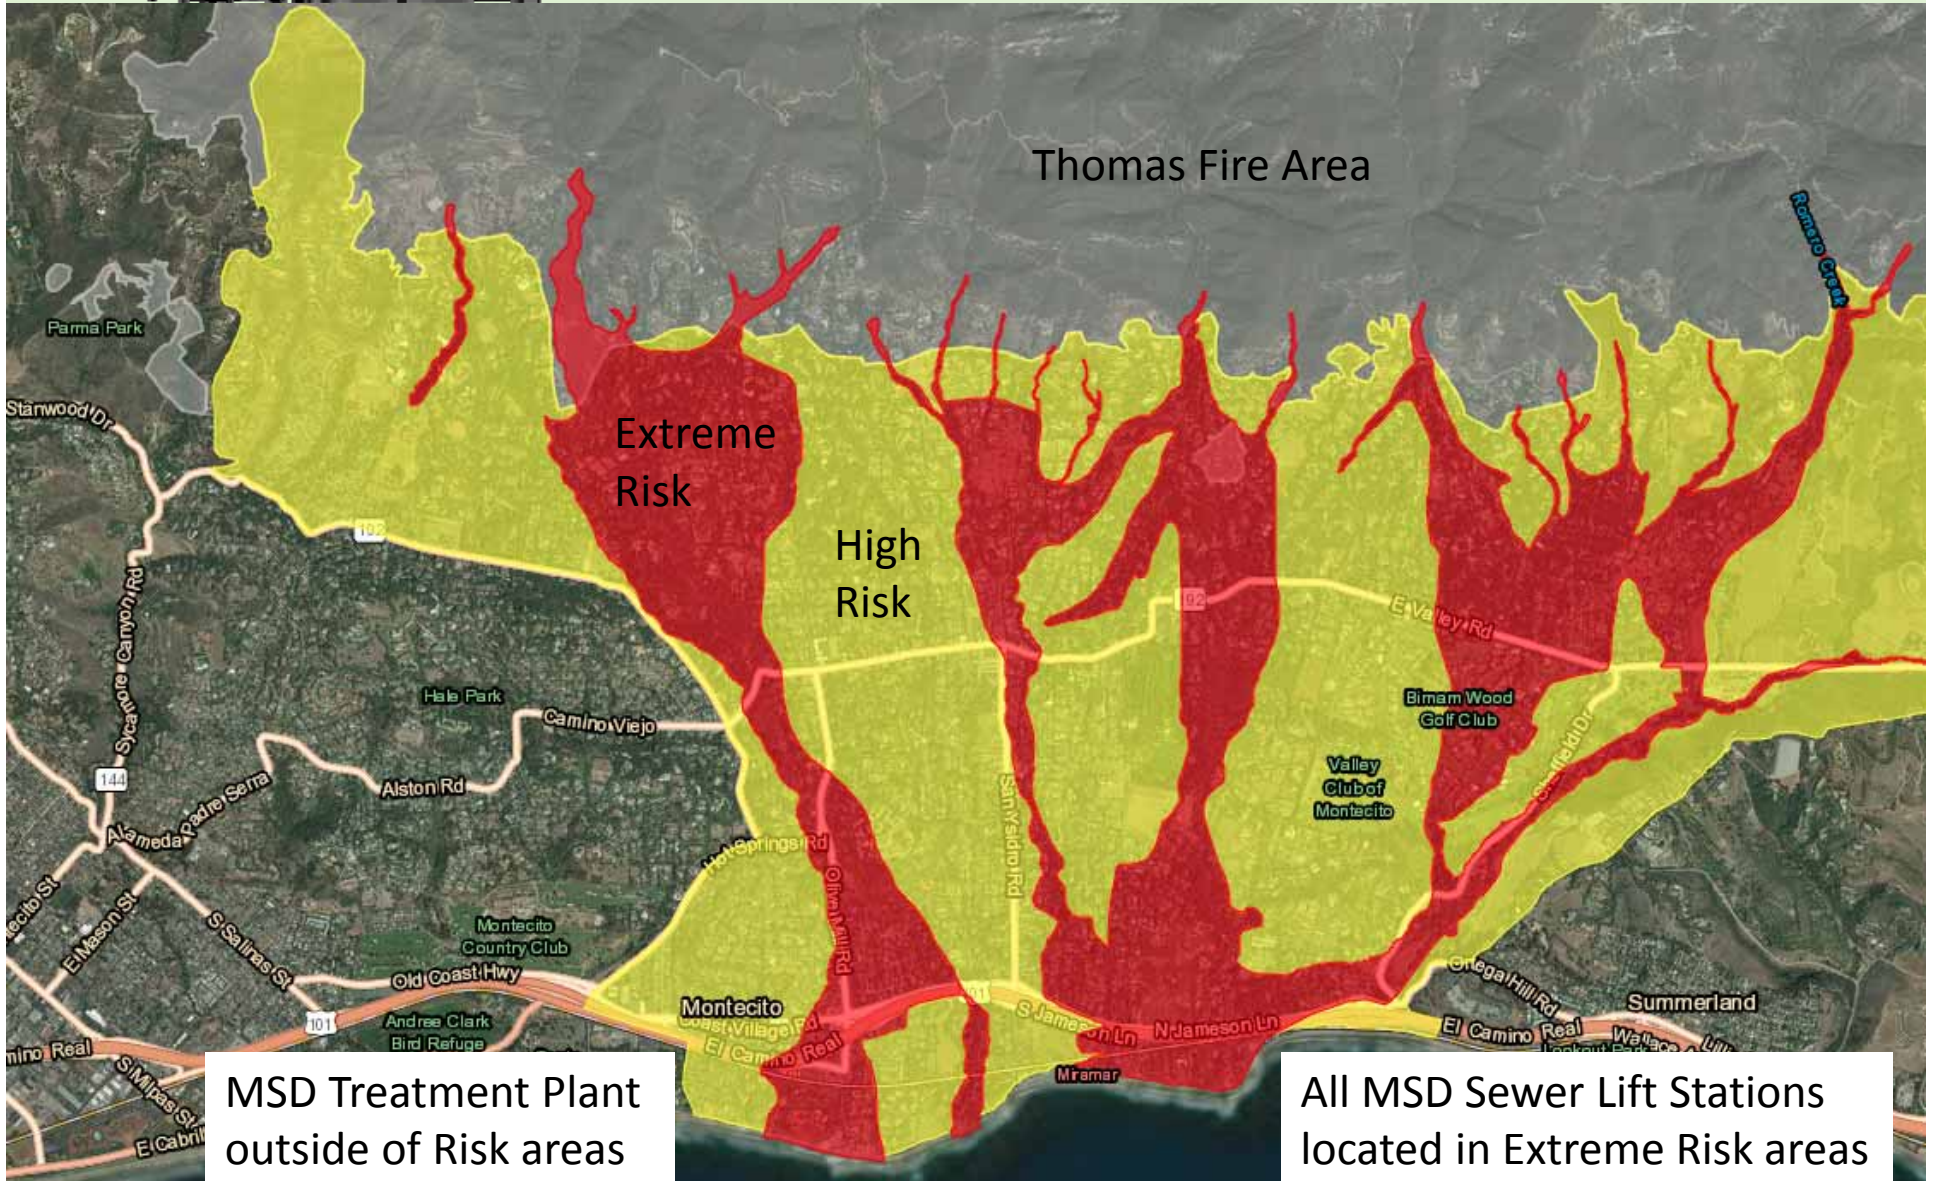
Risk Areas

MSD Treatment Plant
outside of Risk areas

All MSD Sewer Lift Stations
located in Extreme Risk areas

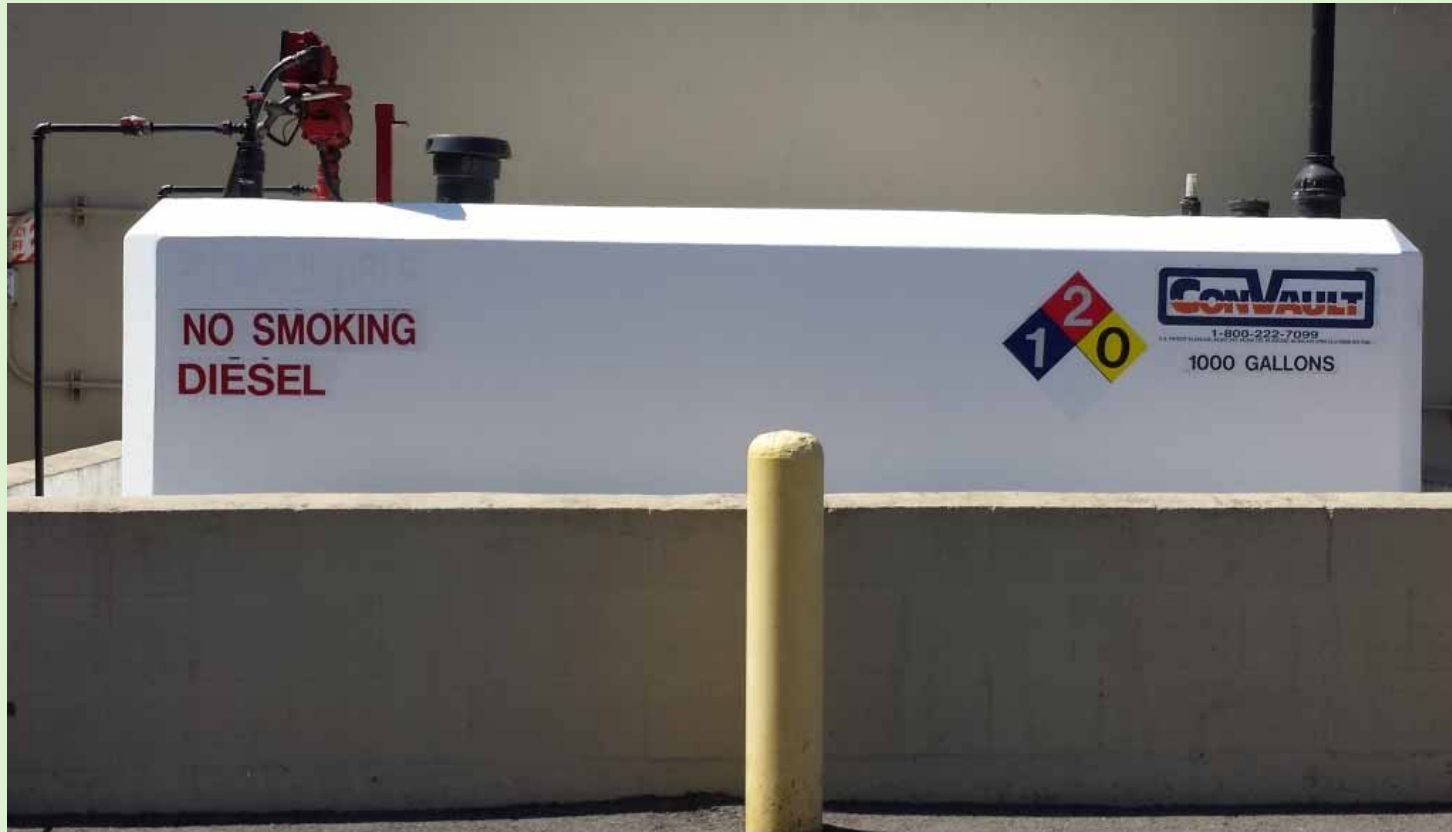
On-Site Diesel Storage

Diesel storage is located at the MSD Treatment Plant for the backup generator.

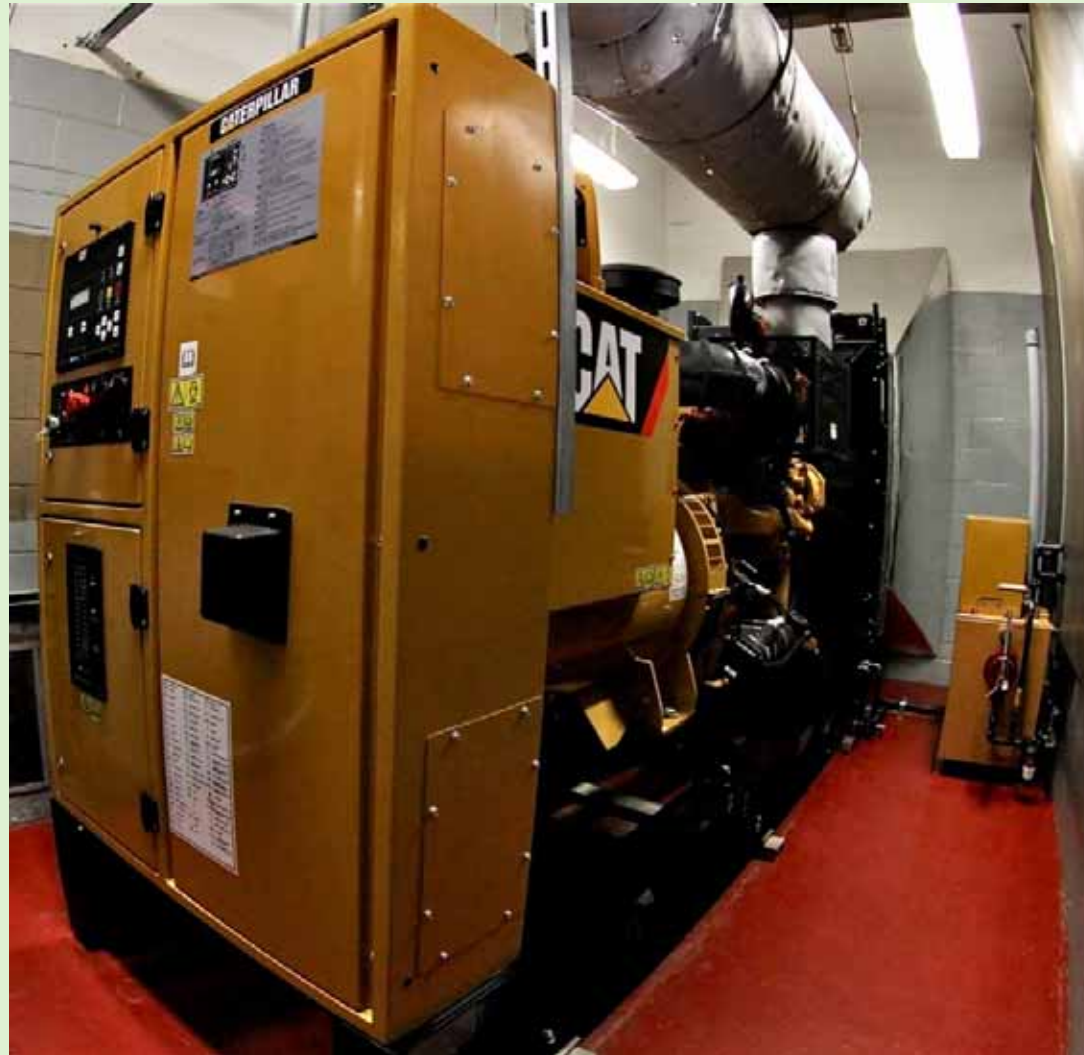
Backup Generator

Diesel Generator has an automatic transfer switch, is capable of powering the entire facility, and is tested monthly

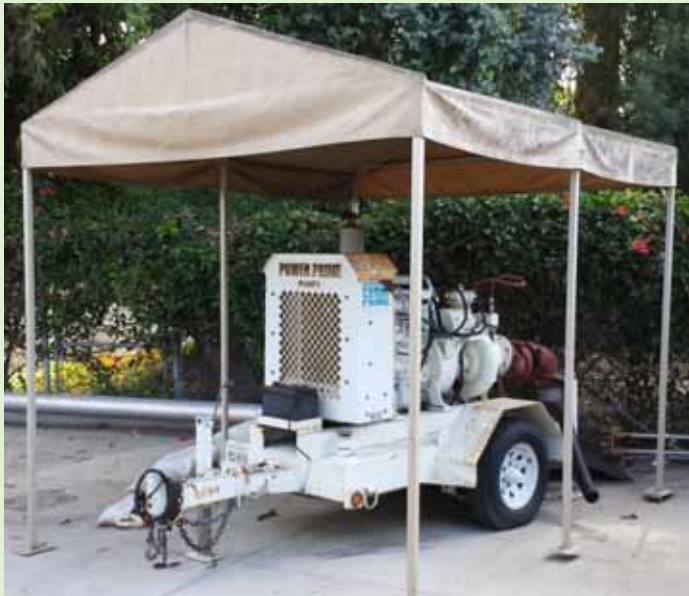
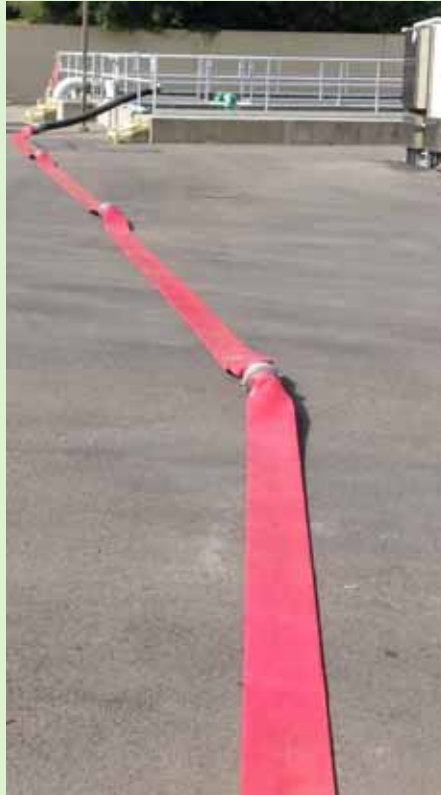
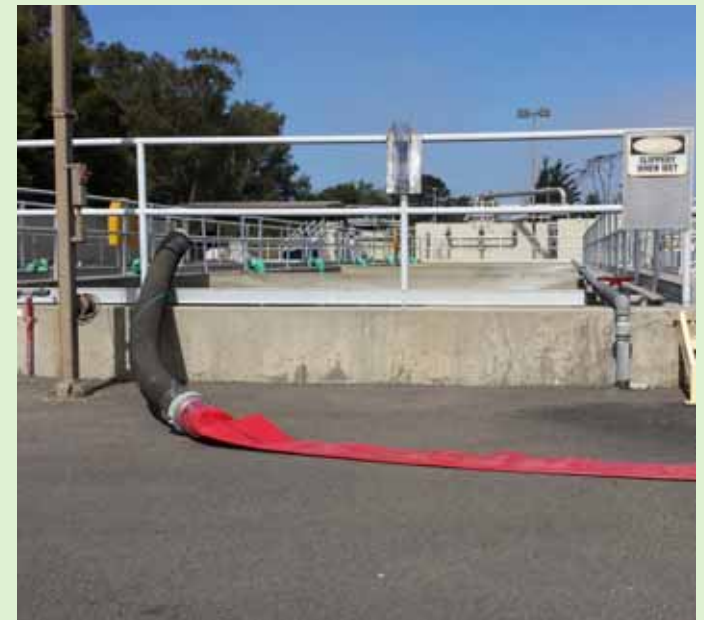
Auxiliary Pump and Piping

An additional auxiliary pump and piping could be used if influent flow to the treatment plant or lift stations are very high.
